### Grinding Noise from Rear Brakes

F80 (M3 Sedan)

F82 (M4 Coupe)

F83 (M4 Convertible)

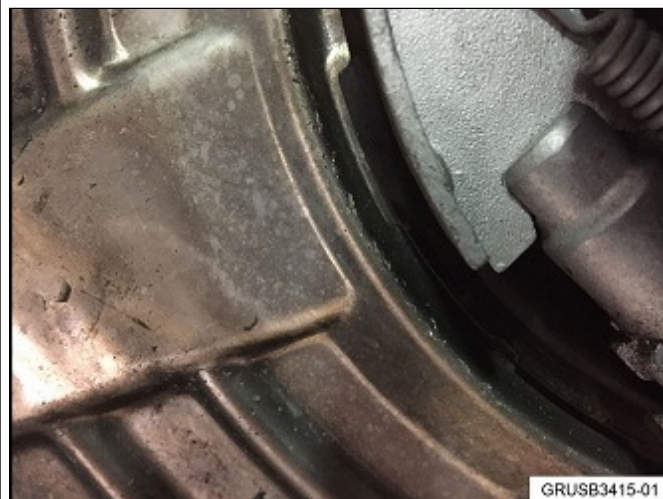
Pebbles, road grit, or other foreign materials caught between the brake protection plate and the brake disc may cause a disturbing noise in the rear axle area.

Check the brake protection plates on the rear axle for damage between the protection plate and brake disc.

If there is visible damage on the brake protection plate, replace both rear axle protection plates with the improved part per REP 34 21 280.

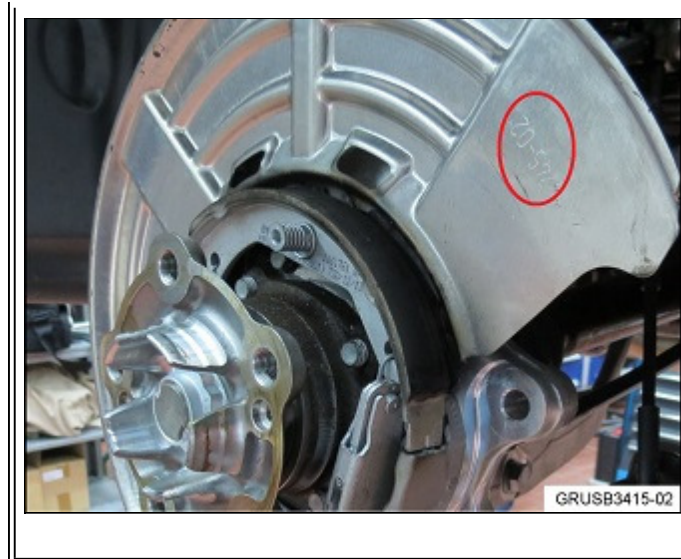
The improved protection plate can be identified by the index “03” stamped after the P/N.  
The old version has an index “02,” as shown in the photo.
