Service Action: Repair the PVC seam on the left A-pillar

F22 (2 Series Coupe)

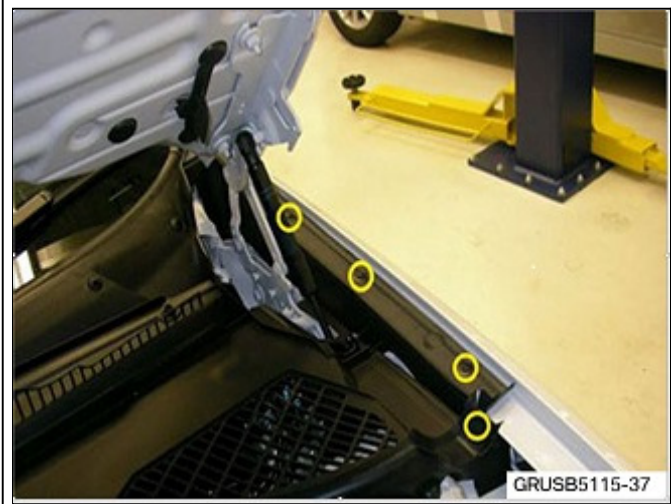
<ol style="list-style-type: none">1. Remove the sealing trim from the left-hand side panel
---	--

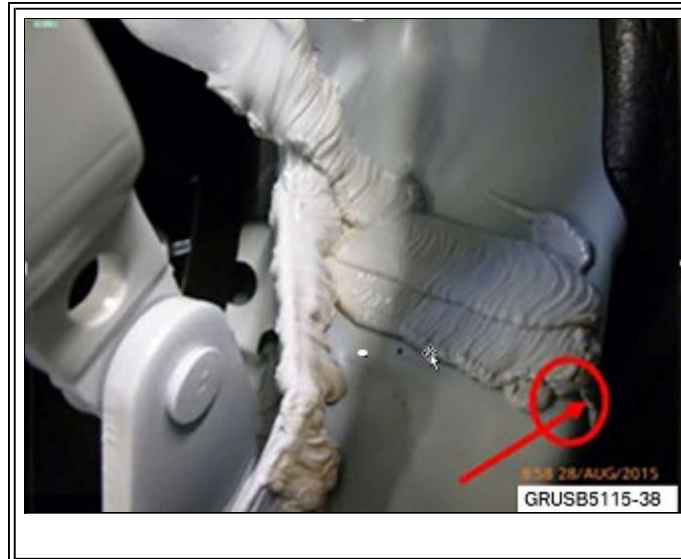
The joint of the bulkhead plate and A-pillar reinforcement is supposed to be sealed with an adhesive strip and a PVC seam. The PVC seam was not applied correctly in places and can cause leaks.

2. **Clean the affected surface and increase the length of the existing PVC seam in the direction of the side panel (see arrow).**

- Note: Push sealant into the gap and smooth out the seam.
