SI B51 36 15
Body Equipment

Service Action: Repair the PVC seam on the left rear light

F82 (M4 Coupe)

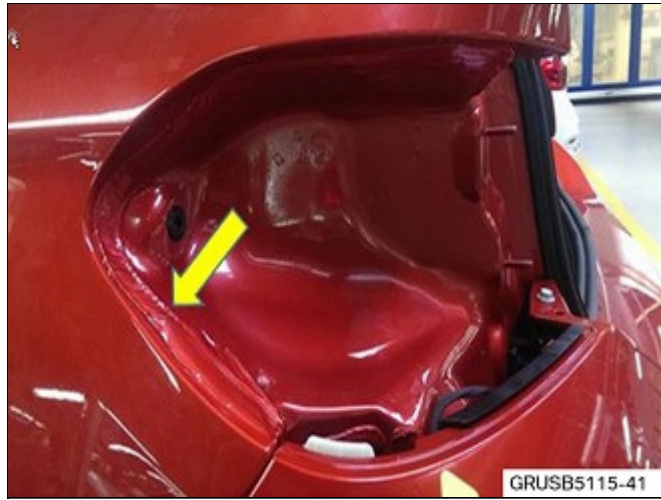
The left rear light PVC seam may not have been applied properly and may be leaking.

The PVC seam was not applied correctly and can cause water leaks.

2. Seal the area of the PVC seam that shows waviness or is incomplete.
