# BMW Motorrad USA

## Service Information Bulletin

**Subject: Ignition remains on when ignition switch is turned off**

**Models:** R nineT (K21)

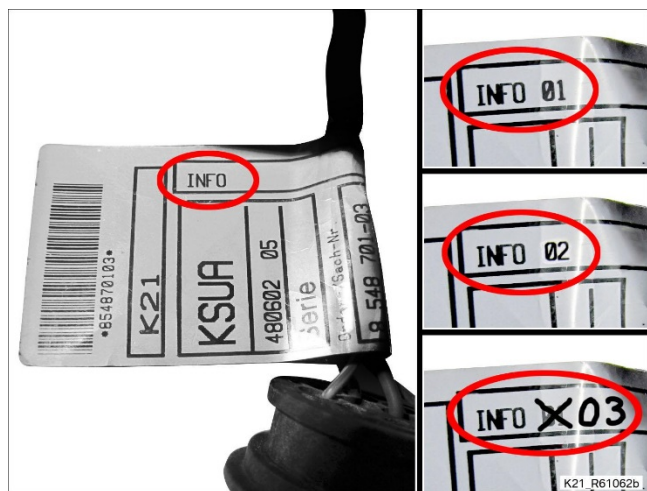
The grey label with the part number is attached to the vehicle wiring harness near the diagnostic connector. Check the "INFO" number to identify the variant.

INFO / INFO **01**: standard wiring harness (part number 61 11 8 548 701) **up to** November 04, 2014

INFO **02**: standard wiring harness (part number 61 11 8 548 701) **from** November 05, 2014 onward

INFO **03**: **From** March 30, 2015 **until** April 01, 2015, the "INFO 01" version of the wiring harness (part number 61 11 8 548 701) was installed together with a retrofitted load-shedding relay (part number 61 12 8 553 659).

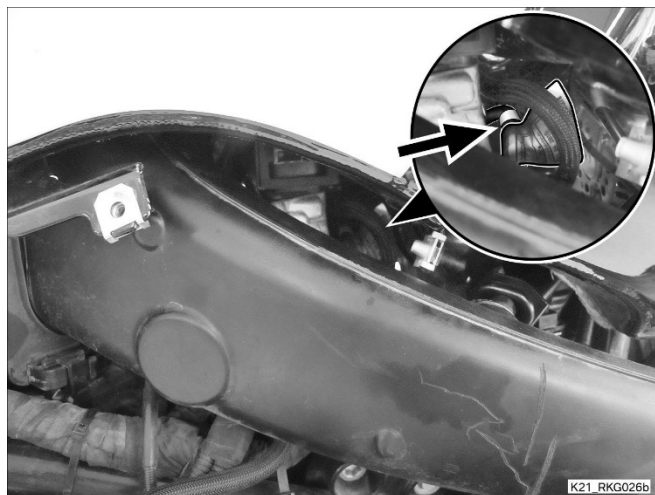
**Note:** Ascertaining whether the load-shedding relay with additional wiring harness has already been retrofitted is a matter of removing the right side cover and visually checking at the right side of the vehicle.

If the grey label of the additional wiring harness and the white mark are visible at the point indicated (arrow), the vehicle is already fitted with the additional wiring harness with load-shedding relay.

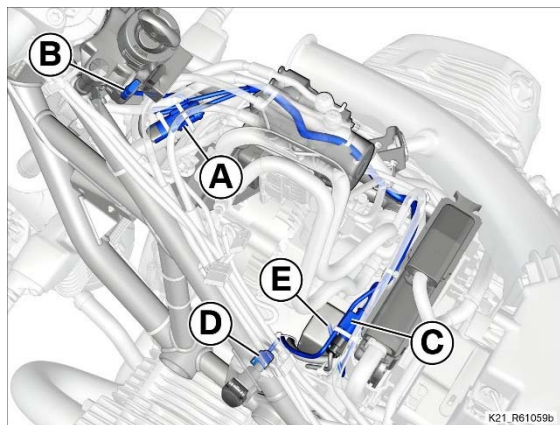
Female adapter (A) for existing connector to ignition switch.

Connector (B) for ignition switch.

Female adapter (C) for existing connector to power socket.

Connector (D) for power socket.

Push-fit contacts (E) for load-shedding relay.

**Service Solution:** In the event of a complaint on a vehicle built before November 05, 2014, install the load-shedding relay retrofit kit and a new ignition switch. Once the system has been modified in this way, the power supply (KL15) of the entire vehicle electrical system is switched via the load-shedding relay. The original ignition switch may have suffered initial damage and is to be replaced as well.
