US 62177457-01

A fault/defect on the right passenger grab handle

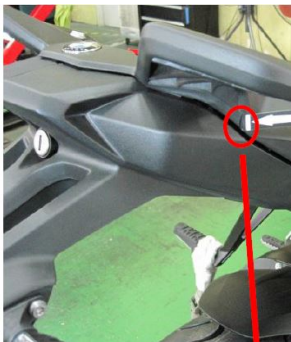
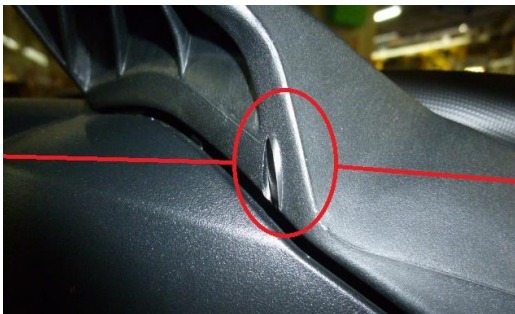
There is a notch visible on the lower part of the right grab handle.

The fault/defect is due to a tooling error.

The rear grab handle (part number 46 54 7 717 014) is to be replaced under warranty.
