Rear Window Defroster is Inoperative

F13 (6 Series Coupe)

Vehicles produced up to June 30, 2015

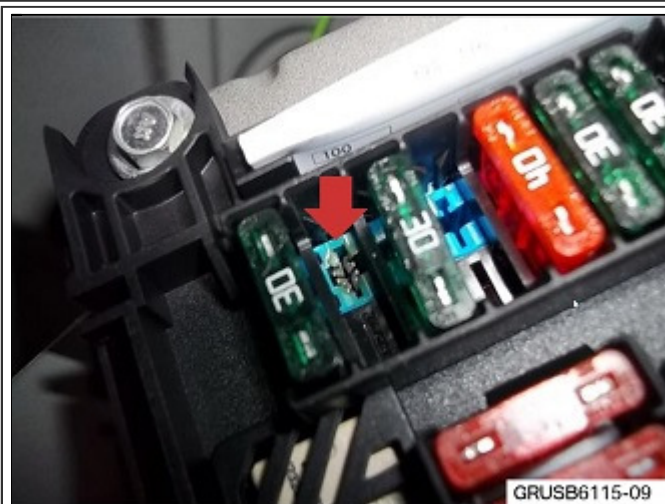
1. Perform diagnosis with ISTA and troubleshoot any related faults.
2. Check Fuse 203 in the rear power distribution box and replace as needed.

3. Check Fuse 203 fuse slot and if there are any signs of overheating, replace the rear power distribution box. Refer to ISTA repair manual "61 13 042 Replace power distribution box (luggage compartment)".

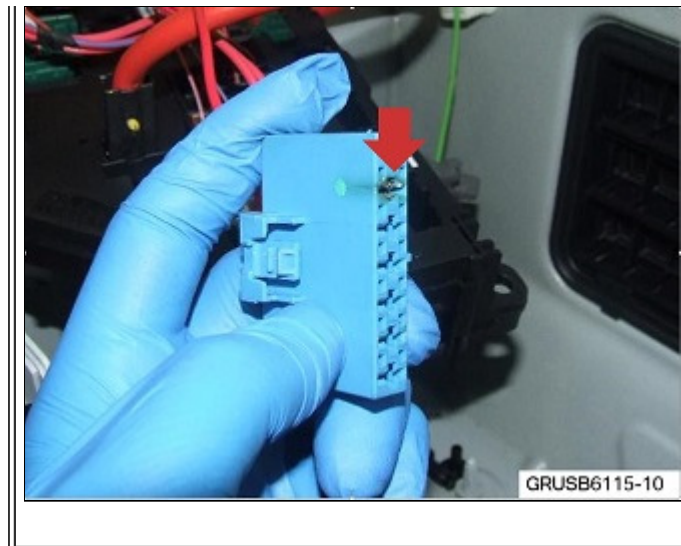
4. Check the connector Z2*4B (7 pin blue) at the rear power

distribution box for any damage and replace the power distribution box and connector as needed.
