This Service Information bulletin supersedes SI B62 07 15 **dated October 2015**

**Instrument Cluster display is partially blank**

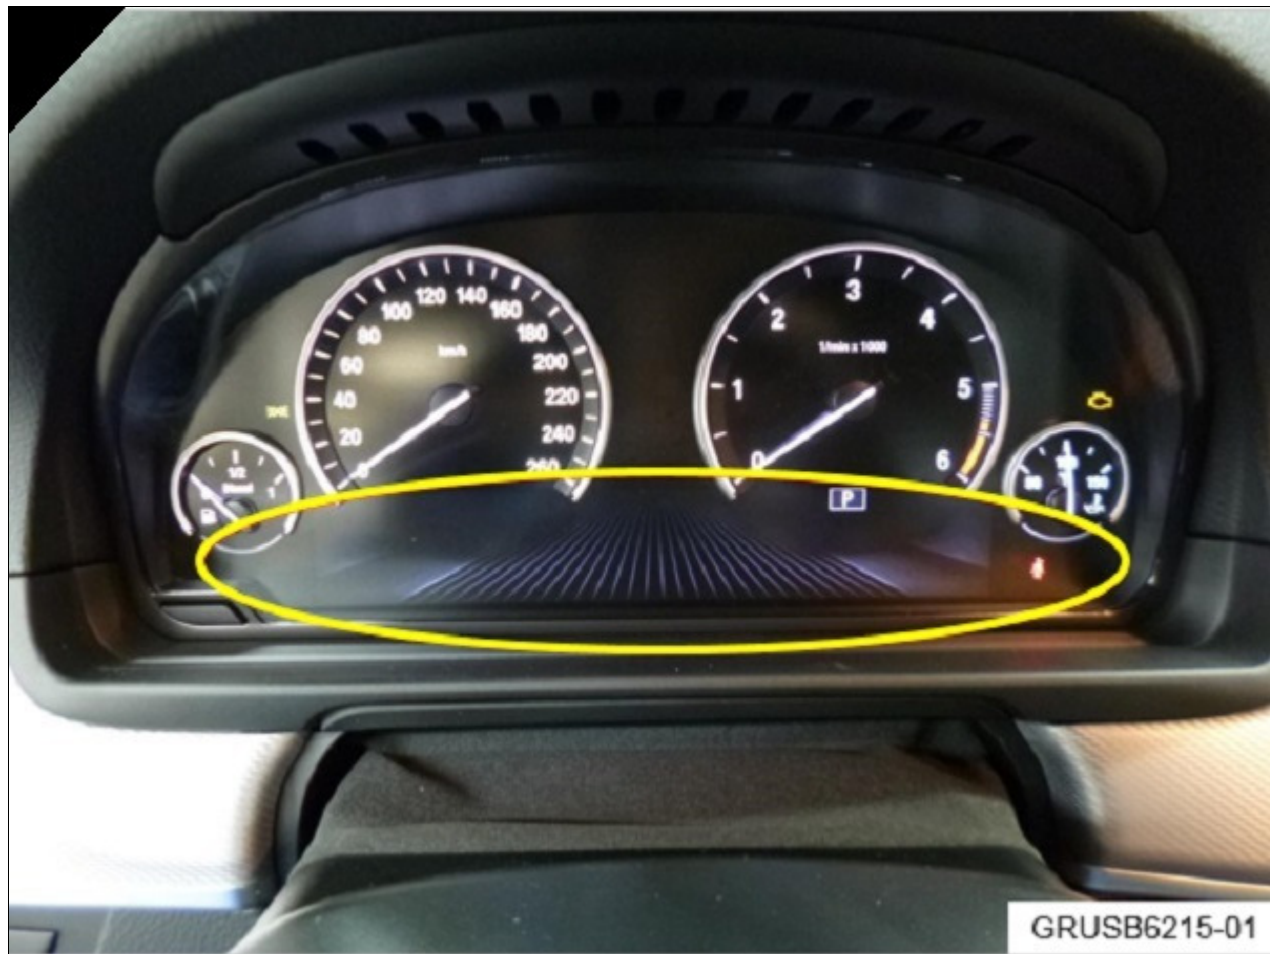
The Instrument Cluster (Kombi) lower display may be intermittently blank. The Board Computer, Ambient Temperature and Check Control Messages will not display.

Instrument Cluster software error.

**NEW** Instrument Cluster must be programmed using ISTA/P V3.57.0 or higher software.

1. Connect the vehicle to ISTA/P.
2. Program and encode the complete vehicle using ISTA/P 3.57.0 or higher.
