This Service Information bulletin supersedes SI B64 06 13 **dated May 2015.**

SUBJECT

A/C Cooling: Intermittent Reduction of Air Flow

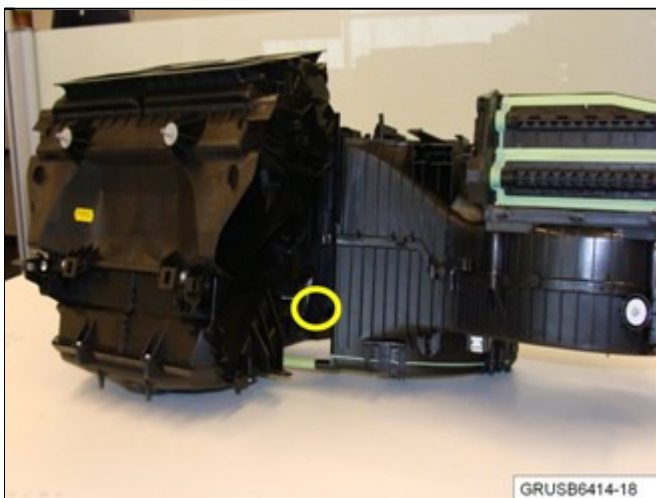
4. The IHKA housing (removed for clarity) shown is viewed from the passenger's side. The circle shows the approximate location of the evaporator temperature sensor.

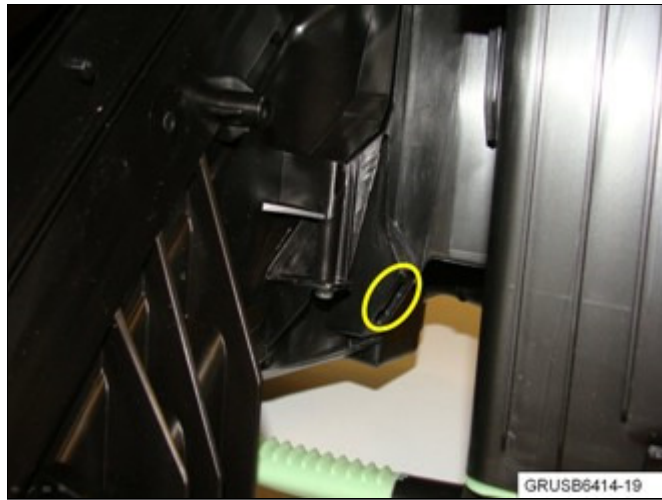
5. The close-up picture shows the exact location (circle) of the sensor opening. The following steps will be performed from the lower passenger's footwell area at the bottom of the IHKA housing.

Note: As a reference point, the evaporator temperature sensor is located just above the white

ribbed rubber water drain hose, when viewed from below.

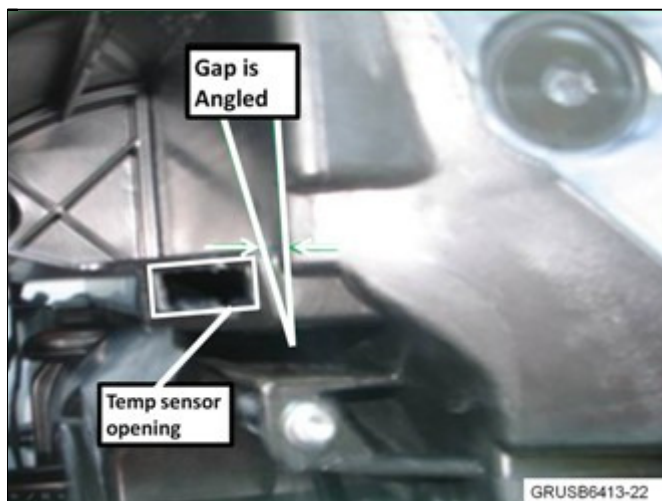
6. Locate the evaporator temperature sensor opening (sensor removed for clarity). Check the gap between the sensor opening and the evaporator case. If the sensor opening contact surface is slightly angled as shown, this housing is **NOT** affected by this repair procedure. In this case, proceed with normal A/C diagnostic procedures.

If no gap exists proceed to the next step.

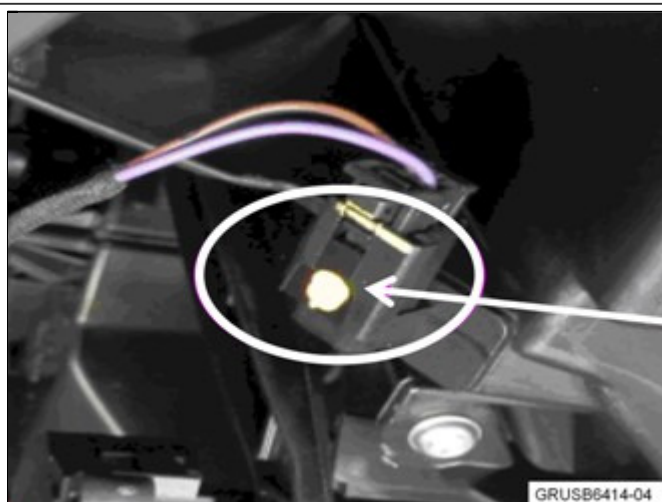
7. Check for a marking on the electrical connector. If a mark is seen or **NO** gap exists, the IHKA housing must be modified.

Do not replace any parts. The repair procedure includes installing a new adapter to correct the gap.
