| Date: November, 2015<br>Bulletin #: 32 002 15 (027) | | Source: BMW Motorrad USA<br>Name: Gordon McDonnell<br>Title: Manager – Service and Technical | | | | |

## Service Information Bulletin

**Subject:** Clutch cable routing

**Models:** F 800 R (K73/02)

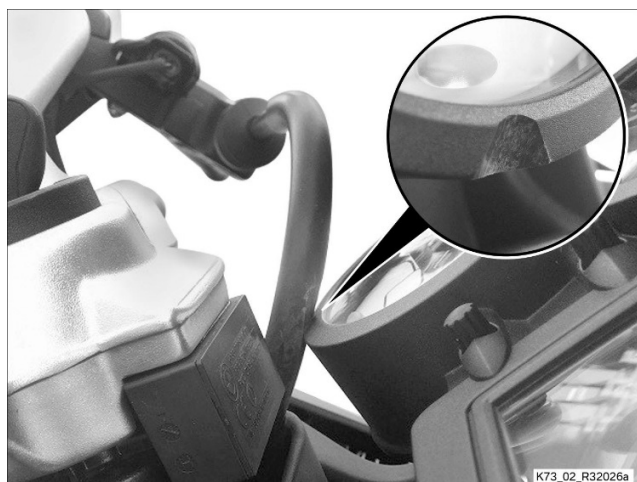
**Details:** Within the framework of quality monitoring, BMW Motorrad has ascertained that the instrument cluster upper housing can be damaged by the clutch cable (see illustration). Installing an extra cable support (Ω-clip) enables the routing of the clutch cable to be corrected in such a way as to prevent it from coming into contact with the housing of the instrument cluster.

Illustration: Damage to upper housing caused by contact with clutch cable

**Service Solution:** In the event of a verified complaint, install the extra hose support (part number: 13 31 1 707 705) (see attached work item 32 73 085 for details). With verified damage to the instrument cluster housing caused by the clutch cable, replace the upper housing. See the description of work item 62 11 590 on the current RSD (Repair and Service Data BMW Motorrad) DVD.
