US 62336252-01

Retaining tabs on the side trim panel break.

Vehicles affected**E series**

K46/12

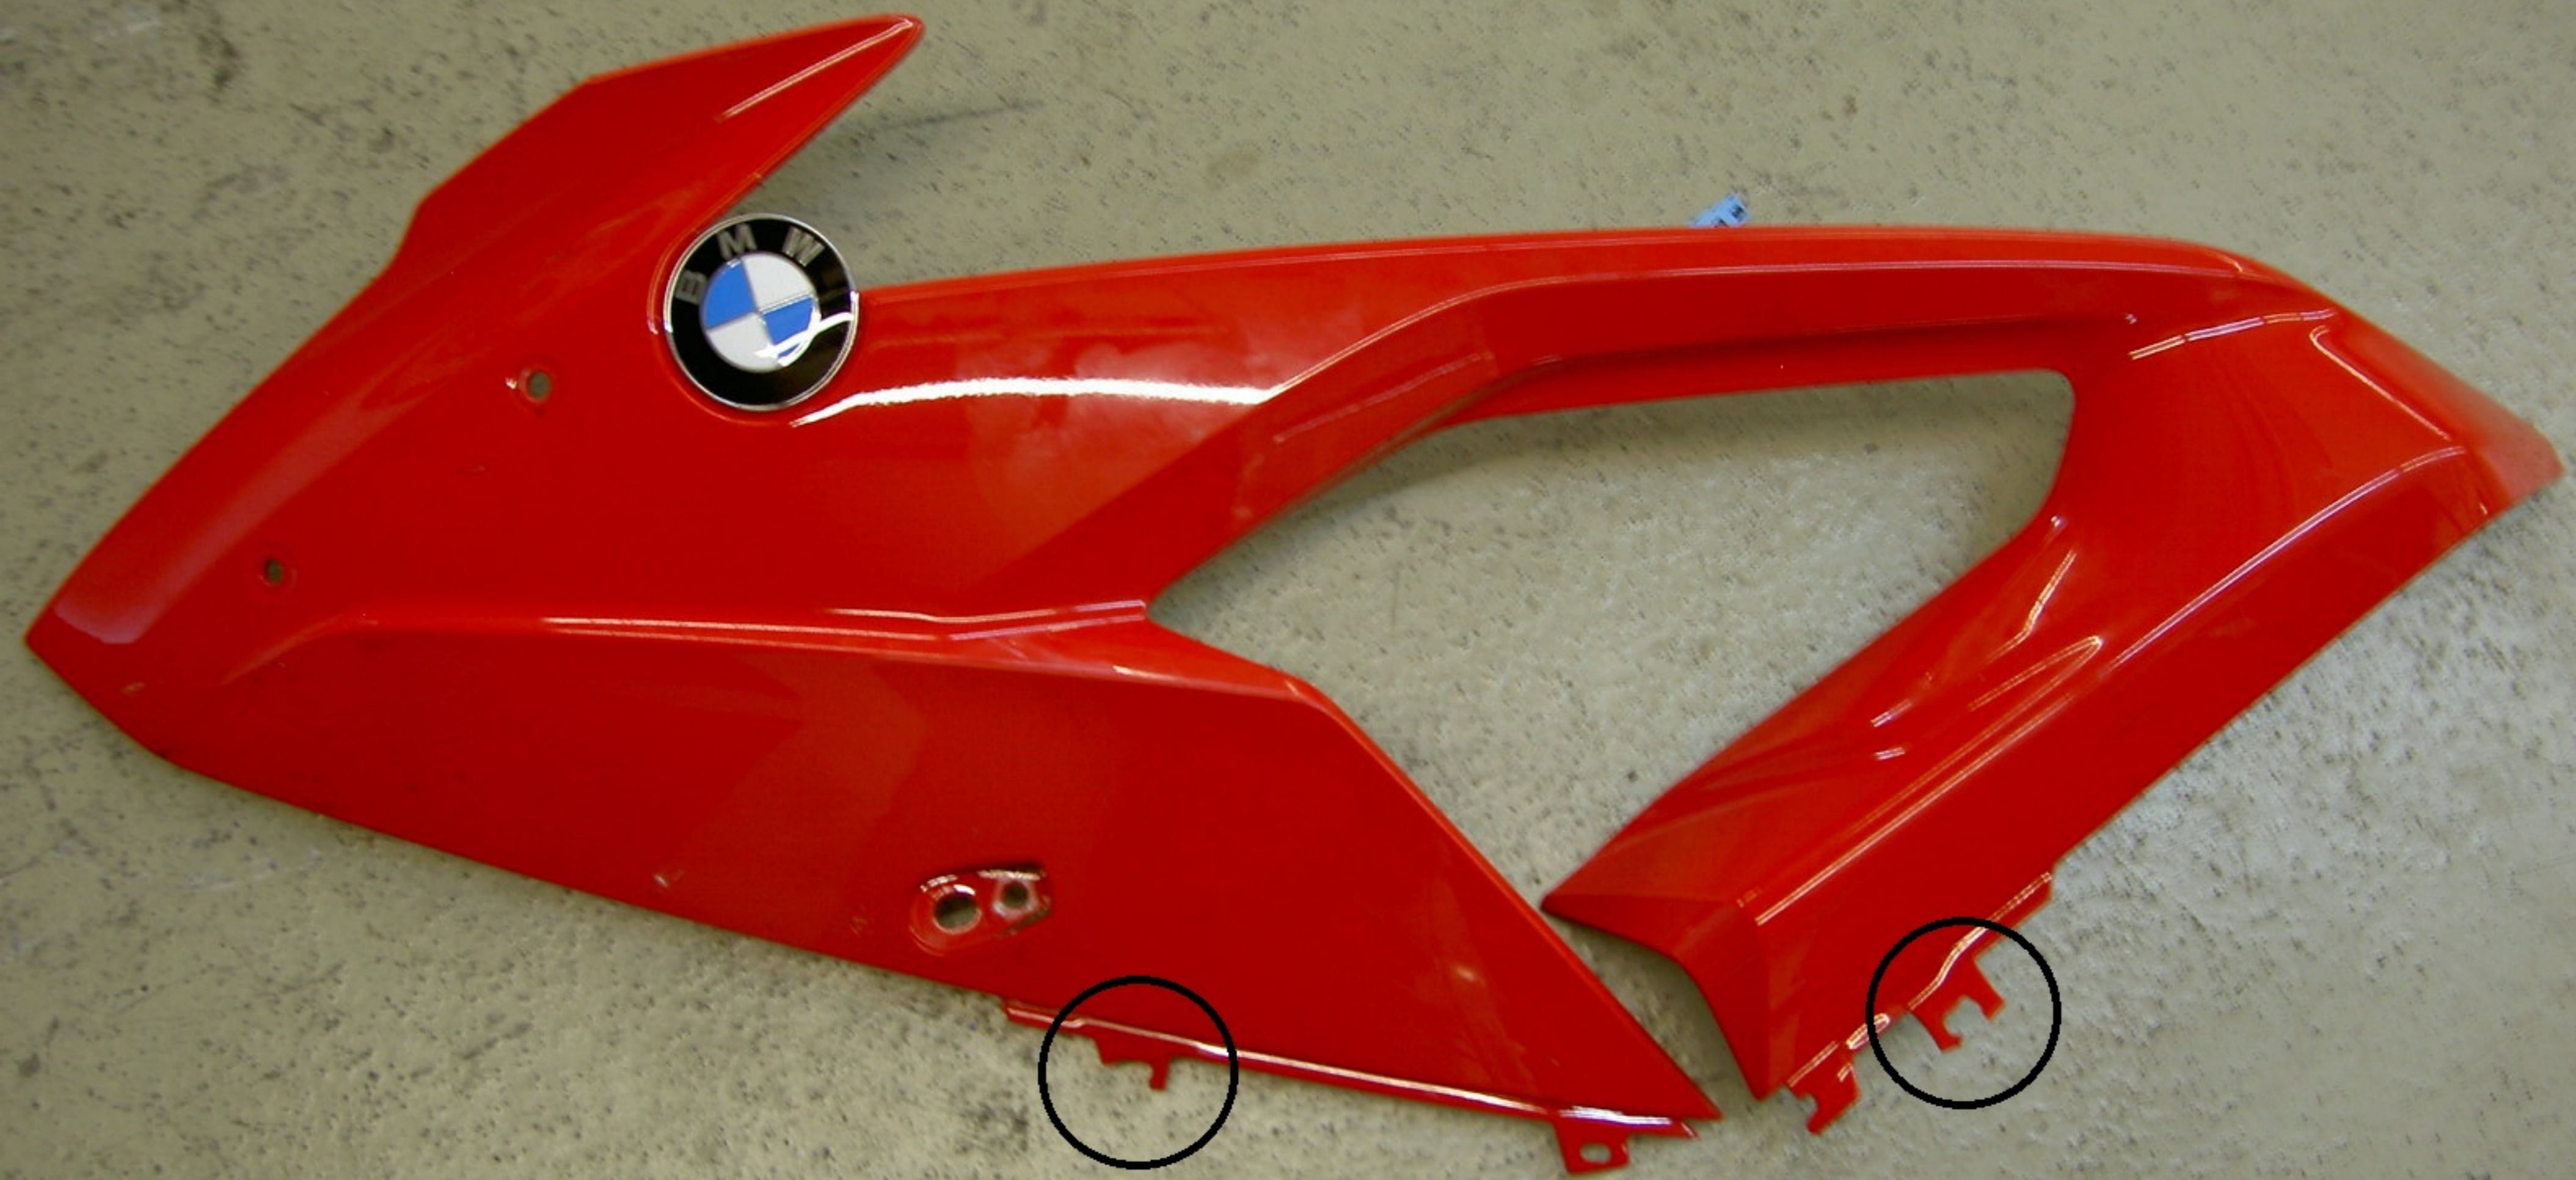
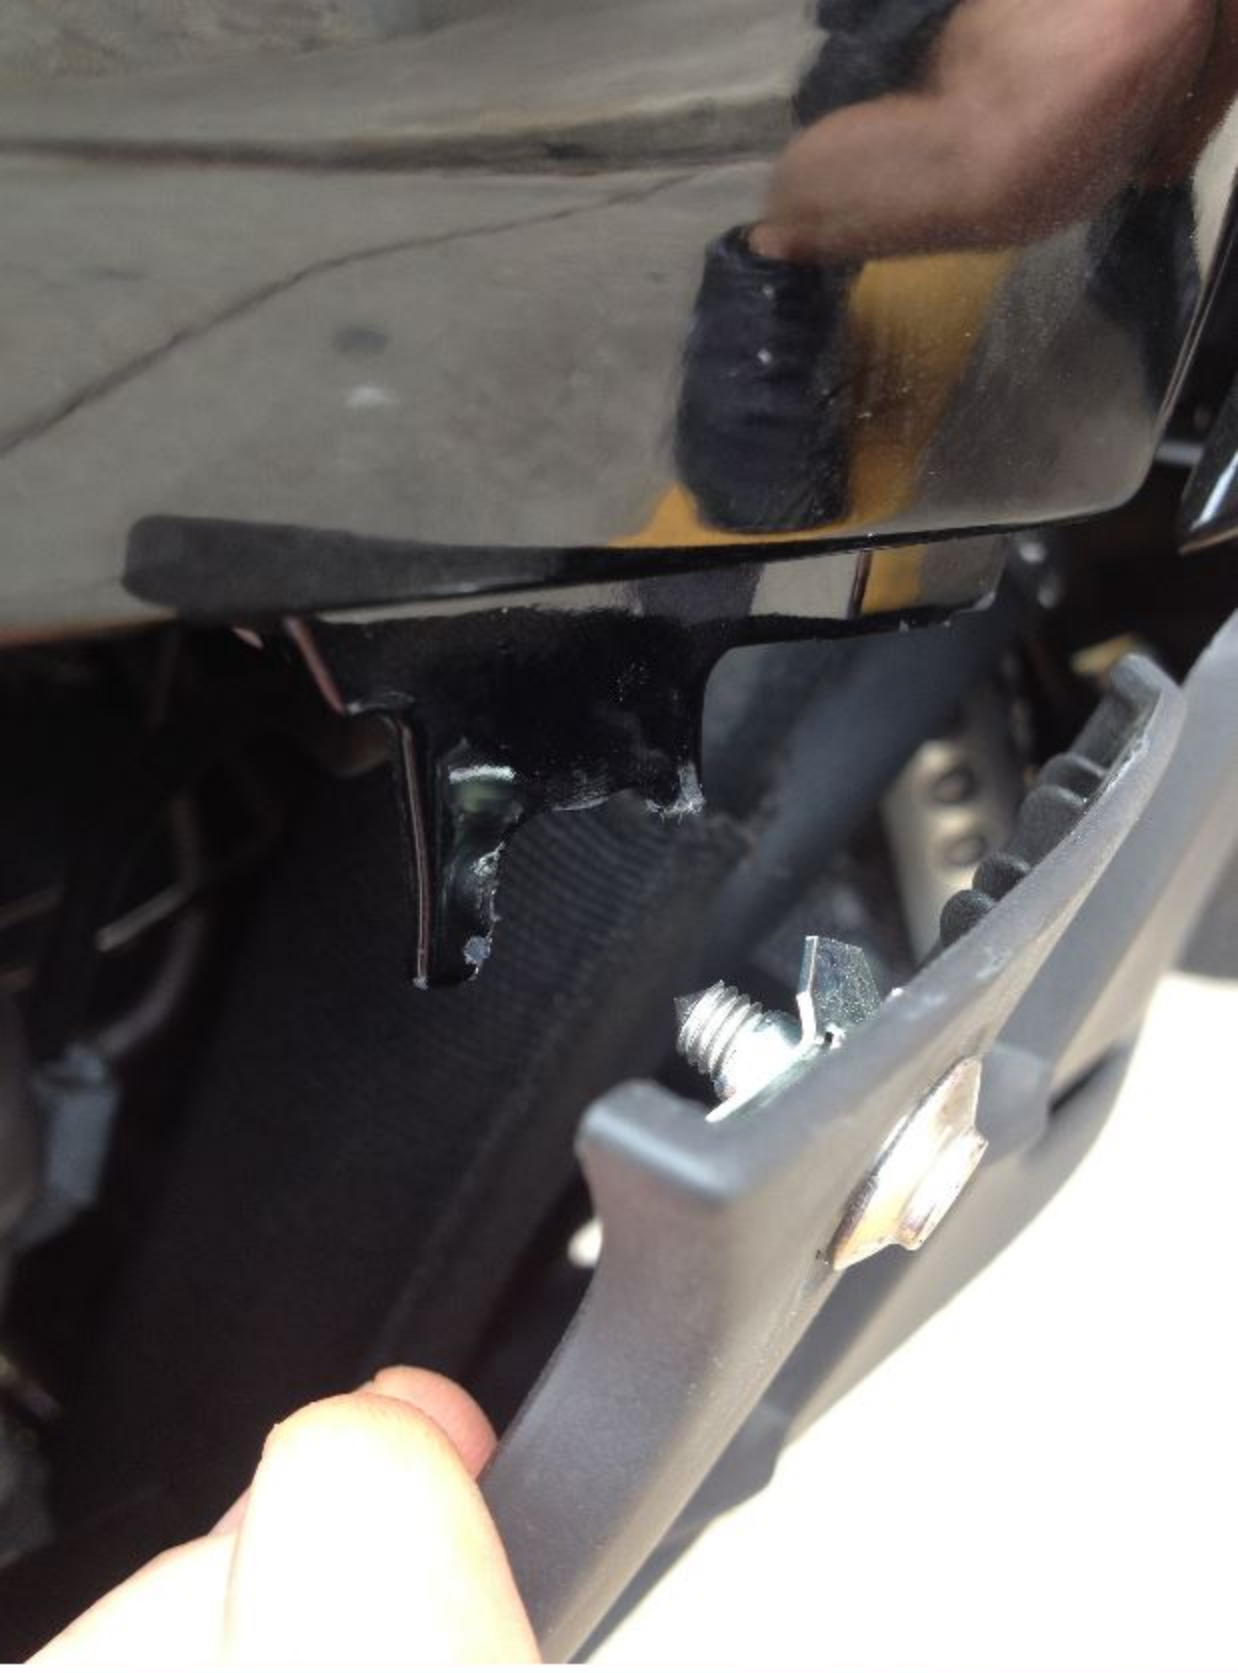
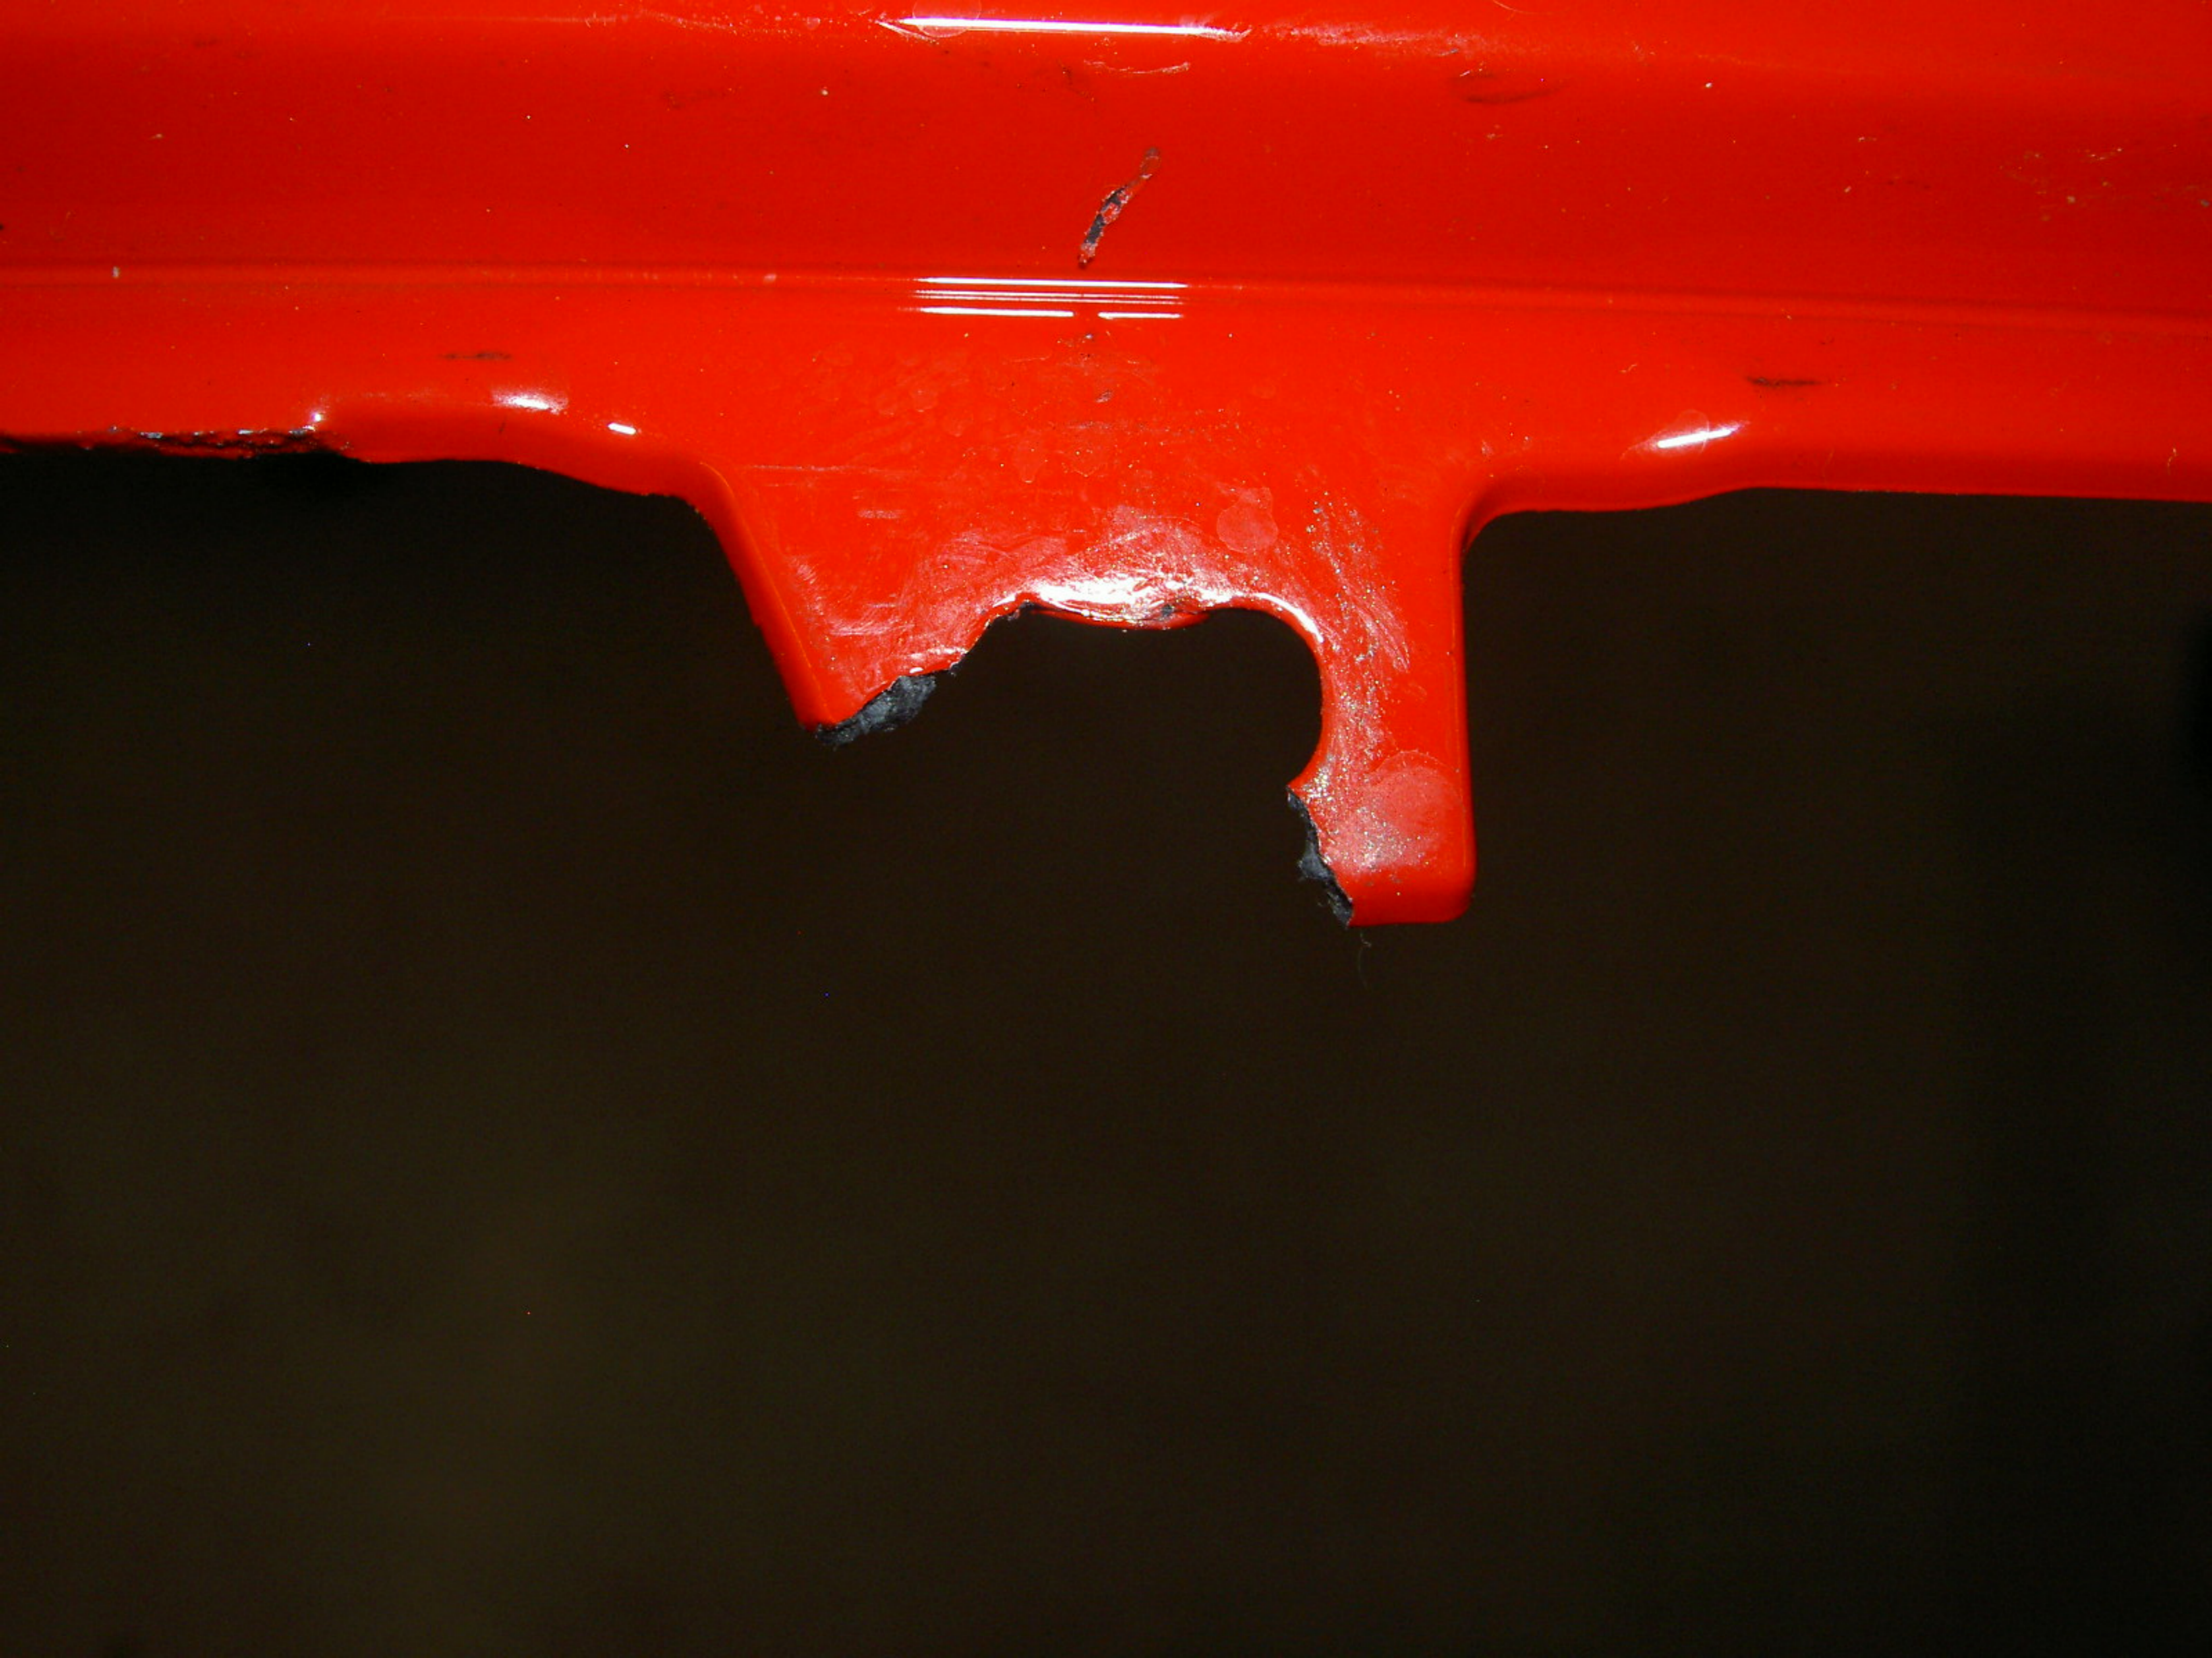
Side trim panel loose

Self-locking expansion nuts transmit an excessively high torque (5 Nm) while being screwed in, which the plastic cannot withstand.

See attached images.

Effective immediately, trim panel collar bolts M5 x 14.5 mm are to be tightened to 2 Nm instead of the previous 5 Nm.
