This Service Information bulletin supersedes SI 34 06 14 **December 2014**.

M5 and M6 Front Axle Brake Squeak with Compound Brake System

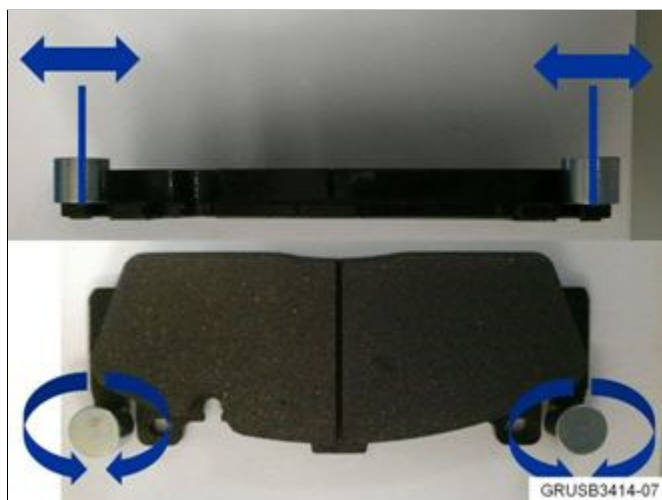
A squeaking noise can be heard when braking from a slow speed. This situation may apply to M5 and M6 vehicles fitted with the metallic brake pads (P/N 34 11 2 284 869). These pads can be identified by the absorber weights at the top and bottom.

1. Check that the brake pads vibration absorbers are firmly installed (no longitudinal, or rotational movements are detected). These absorbers must be seated correctly to perform their proper operation.

In case the pads vibration absorbers are found to be loose, brake pads need to be replaced.

NEW Follow the brake pads/calipers installation procedure (lubrication and positioning) found in the attachment “B340614_PadsCalipers_Positioning”.
