This Service Information bulletin supersedes SI 34 08 14 **dated July 2015**.

Ticking Noise from Front Axle When Cornering

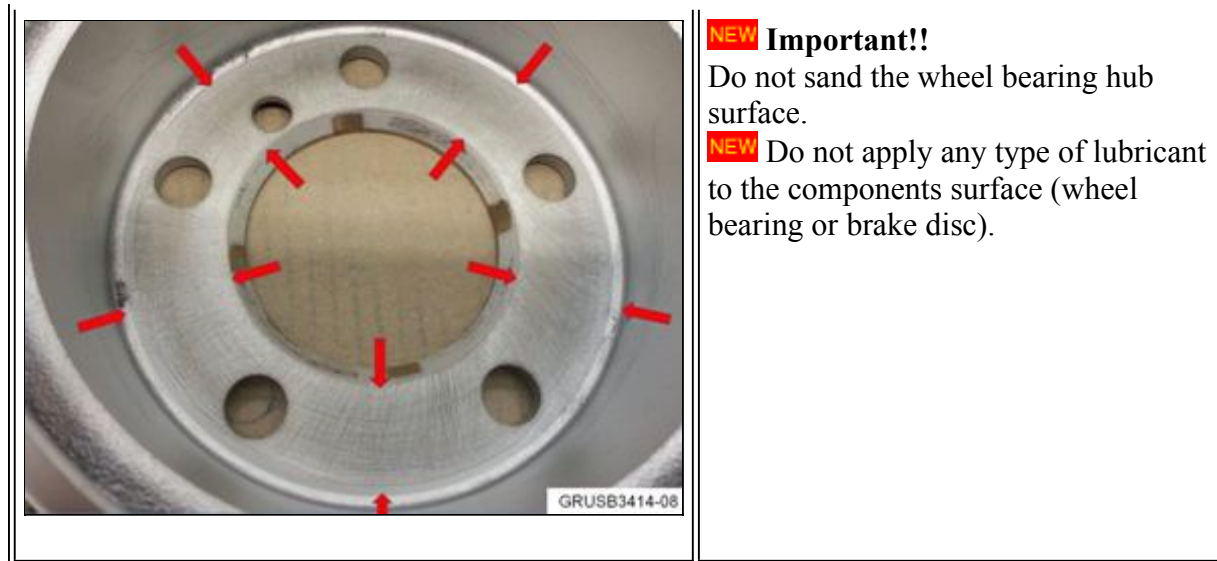
The customer may complain of a ticking noise from the front axle when cornering, maneuvering, parking or pulling away from a parking space. The noise can be heard as a light metallic ticking from the front outer cornering wheel.

Movement between the brake disc and wheel bearing hub.

NEW Using 80-grit sandpaper, sand the contact surface of the **brake disc** to the wheel bearing hub.

NEW Sand the surface in a radial motion (inside to outside around the surface).

NEW Clean the wheel bearing hub surface with brake cleaner.

Do not sand the wheel bearing hub surface.

NEW Do not apply any type of lubricant to the components surface (wheel bearing or brake disc).
