Groaning noise from A-pillar Door Stops

F33 (4 Series Convertible)

F83 (M4 Convertible)

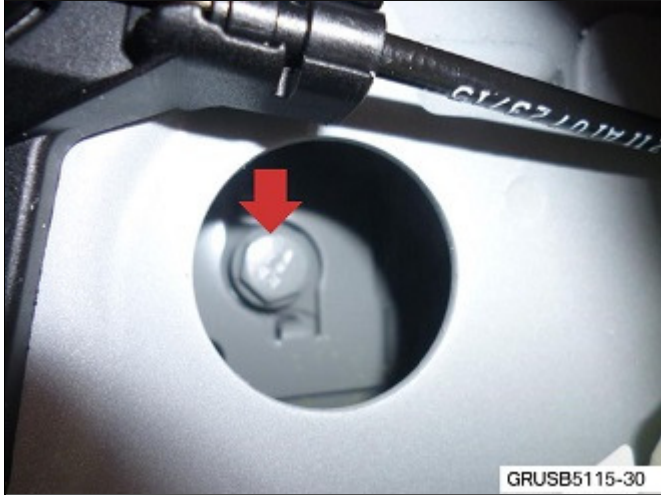
A groaning noise can be heard from the A-pillar area near the front door stop when one of the front doors is opened, or when the vehicle is driven on rough roads.

The bolted connection for the lower hinge at the area of the A-pillar is loose, or can flex causing a groaning noise.

<p>The driver side is shown for reference only</p> <p>Note: Support the door from sagging once the bolt is loosened.</p> <p>Loosen the bolt by a half turn.</p> <p>Spray a thin coat of Universal lube around where the bolt meets the body.</p> <p>Tighten the bolt to 60 Nm.</p> <p>Verify that the noise is gone.</p> <p>The 2 next steps are necessary since the door might have moved slightly during the repair:</p> <ul style="list-style-type: none"> • Check that the door adjustment is proper. • Reinitialize the power window for that door. <p>Install the previously removed side panel trim.</p>
---	---
