SI B51 40 15  
Body Equipment

**Inside Front Door Handle Makes Cracking Noise**

I12 (i8)

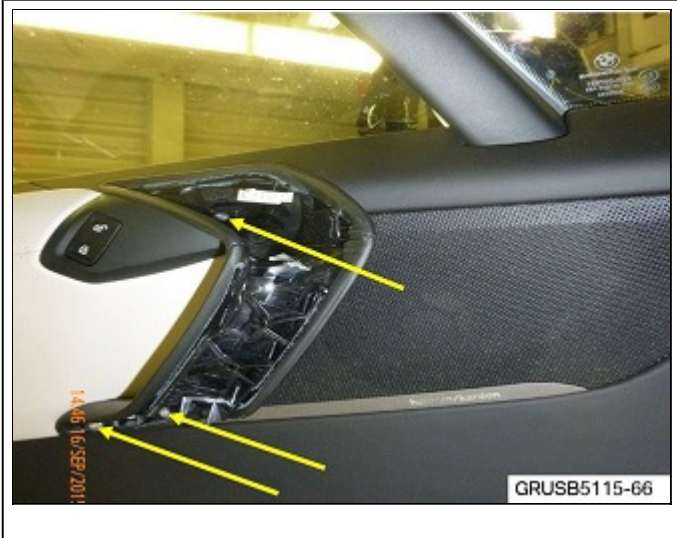
Front door trim panel loose on right or left side.

The repair procedure shown is for the left or right door. Both front doors could be affected.

<p>Use Repair Instruction REP 51 41 000 “Remove and install / replacing the left or right front door trim”.</p> <p>Retighten the three screws on the handle trim to a torque value to 2.6 Nm.</p> <p>Confirm the crackling noise is gone. <b>If noise is still present</b>, replace the three screws with part number 07 14 9 909 368 and torque to 3 Nm.</p>
--	---
