This Service Information bulletin supersedes SI B52 04 12 **dated July 2012.**

Front Seat Base Makes Noise

F01 (7 Series Sedan)

F10 (5 Series Sedan)

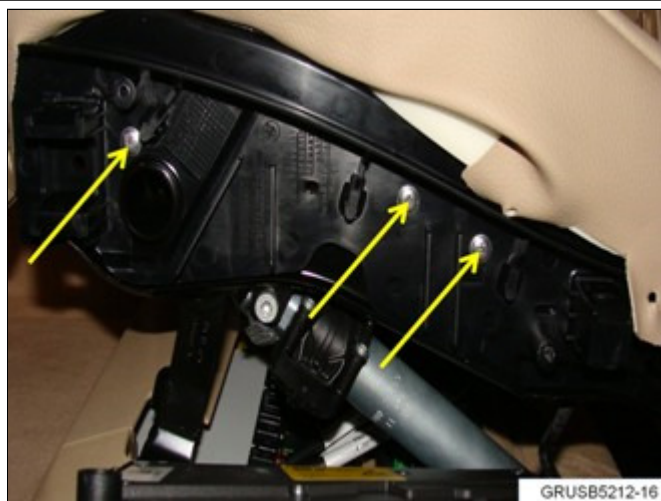
The riveting of the seat control bracket to the metal seat base is too loose.

4. Drill out the 3 rivets and pull back the top of the black plastic panel.
