SI M11 08 15  
Engine

### Surface Cracks on the Water Pump Drive Pulley

R55 (Cooper, Cooper S, Cooper S JCW)

With the N16 or N18 Engine

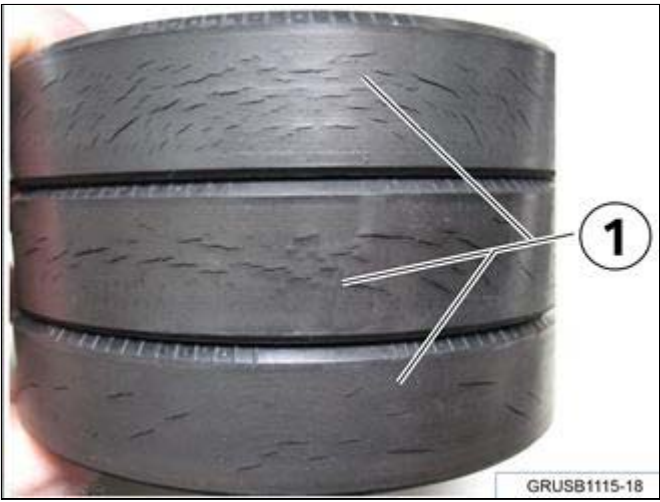
During a repair, service or inspection, the drive pulley on the water pump shows signs of cracking.

<p>Surface cracks (1) form on the drive pulley over time. <b>These cracks are normal and have no effect on the integrity of the friction surface</b></p>
---	--

No part replacement is necessary unless there is another issue found that will be corrected by replacing the drive pulley.
