US 62332524-01

Transmission Downshifting

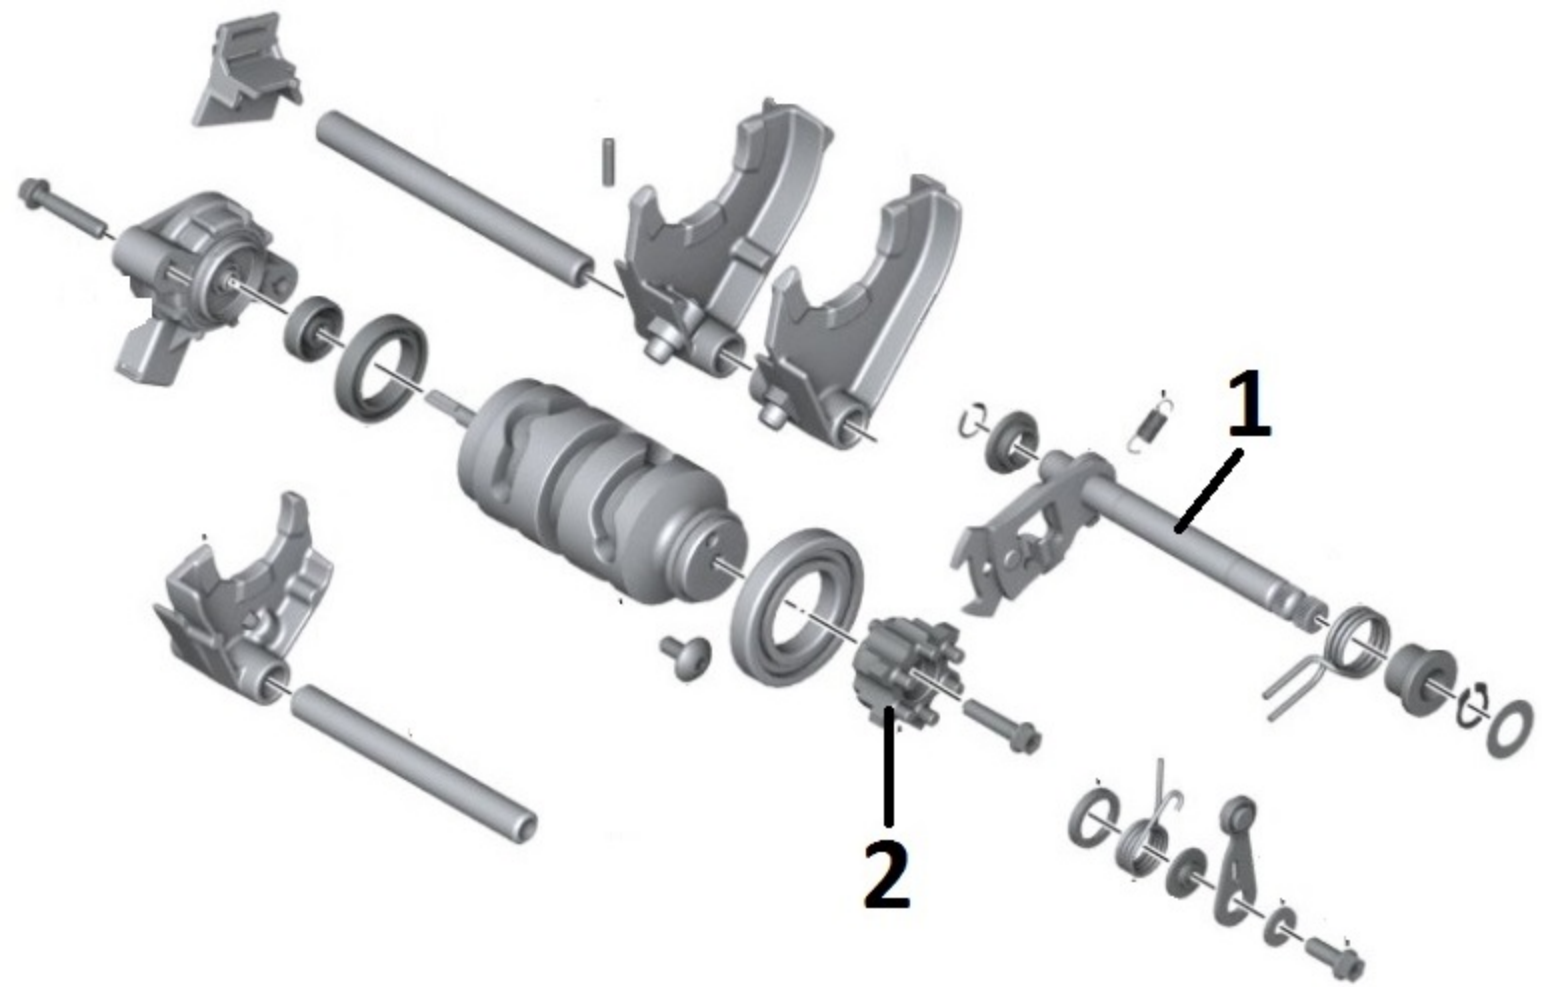
Occasionally it's not be possible to downshift the transmission; especially from 3rd to 2nd gear.

Gearshift shaft and free gearwheel.

The vehicles affected are those produced in 2015.

With a verified customer complaint by a BMW certified technician and confirmed via puma exchange, replace the gearshift shaft and free gearwheel.

See image in the accompanying picture, parts 1 and 2.

Note: The transmission does not have to be disassembled.
