NUMBER: 23-001-15

DATE: January 09, 2015

Lower Center Instrument Panel Bracket Fasteners Loose

2015 (DS) Ram 1500 Pickup

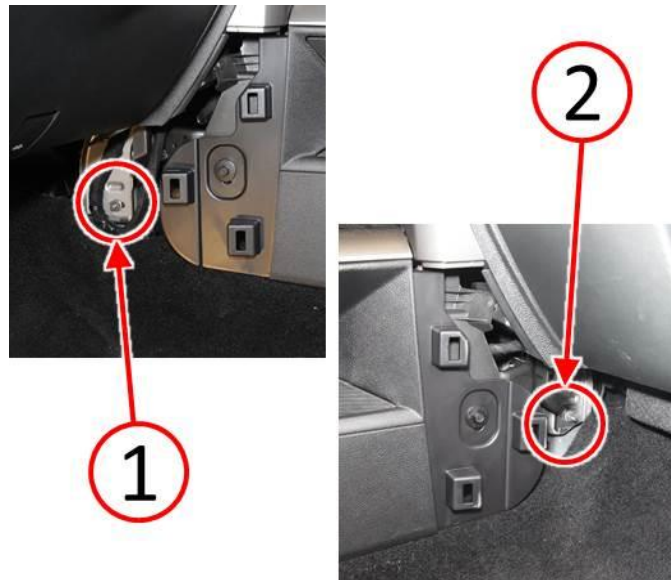
Fig. 2 Lower Center Instrument Panel Fasteners

The lower center instrument panel fasteners were left loose during vehicle assembly. This condition may result in a buzz, squeak, or rattle noise coming from the lower center instrument panel area.

-
2. Tighten both the left side (1) and right side (2) lower instrument panel bracket fasteners to 12 N·m (9 Ft Lbs) (Fig. 2).
