NUMBER: 08-004-15

FLASH: Battery Electric Vehicle, Multiple System Enhancements

2013 - 2015 (FF) Fiat 500e

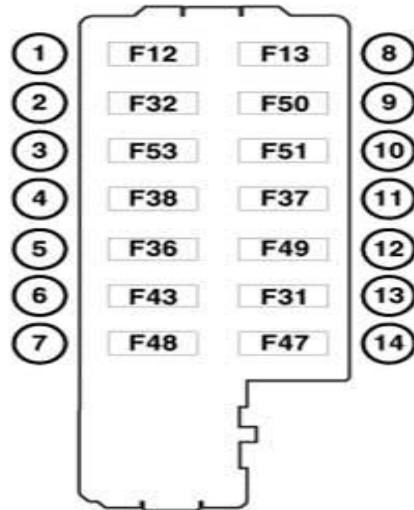
Fig. 1 Interior Fuse Panel Located By The Left Kick Panel.

NOTE: Sometimes when updating the software on these modules, the CTM may stop communicating and/or U11F6-00 is set as an active fault. Pulling the fuse for the CTM will regain communication with that module and change U11F6-00 to a stored DTC.

15. Is U11F6-00 set as an active fault?
 - a. Yes >>> Proceed to [Step #16](#).
 - b. No >>> Proceed to [Step #18](#).
16. Turn off the ignition and pull fuse F36 for 10 seconds. It is located in the interior fuse panel, which is part of the BCM, see ([Fig. 1](#)).
17. Turn the ignition back on and check if U11F6-00 is now set as a stored fault?
 - a. Yes >>> Proceed to [Step #16](#).
 - b. No >>> This bulletin has been completed. Perform normal diagnostic, Follow TechConnect > U11F6-00-LOST COMMUNICATION WITH CONVERGENCE TELEMATICS MODULE.
18. Clear any DTCs that may have been set in other modules due to reprogramming. The wiTECH application will automatically present all DTCs after the flash and allow the tech to clear them.

13. Is U11F6-00 set as an active fault?
 - a. Yes >>> Proceed to [Step #14](#).
 - b. No >>> Proceed to [Step #16](#).
14. Turn off the ignition and pull fuse F36 for 10 seconds. It is located in the interior fuse panel, which is part of the BCM, see ([Fig. 1](#)).

Remove fuse F36 .
