NUMBER: 08-082-15

DATE: September 02, 2015

Missing Navigation Feature

2015 (UF) Chrysler 200

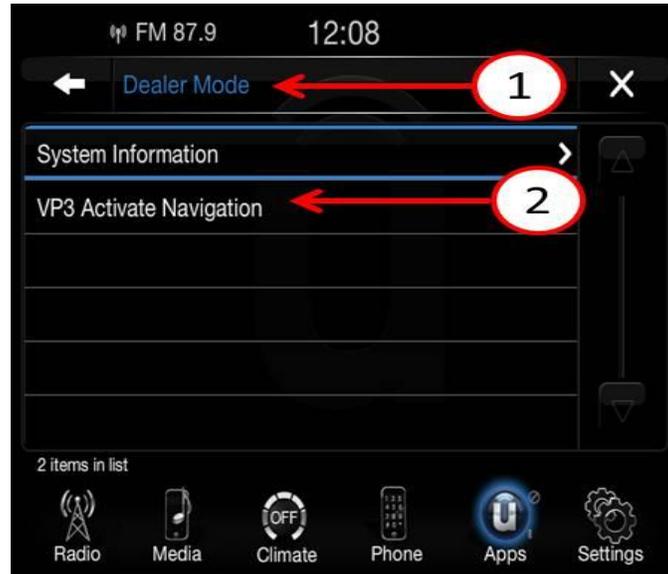
Fig. 1 Screen showing the Radio is in dealer mode

- 1 - Dealer Mode
- 2 - Select this to get request code

1. Turn the ignition on.
2. Put the radio into dealer mode. At the same time press and hold the 3 hard keys under the audio screen, Driver side Temp up, Temp down and Front defrost button. When the dealer mode has been accessed, this screen will appear, see (Fig. 1).

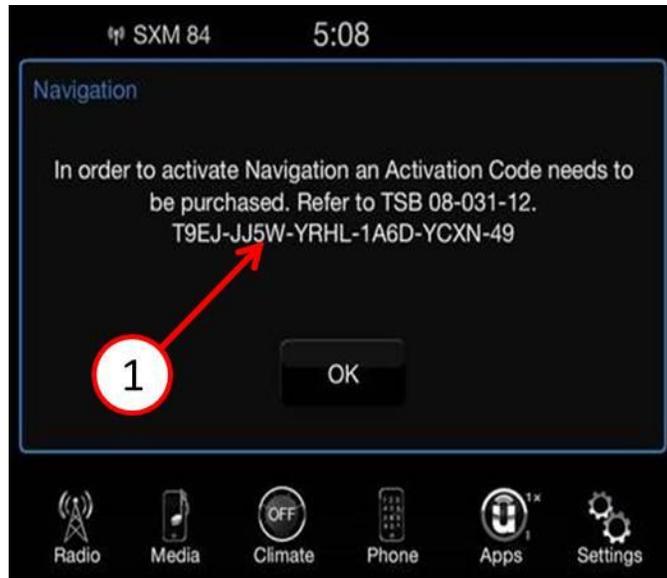
Fig. 2 Request code

1 - 22 position Request Code.

-
3. After selecting “VP3 Activate Navigation”, a screen with a 22 position request code will appear, see (Fig. 2).

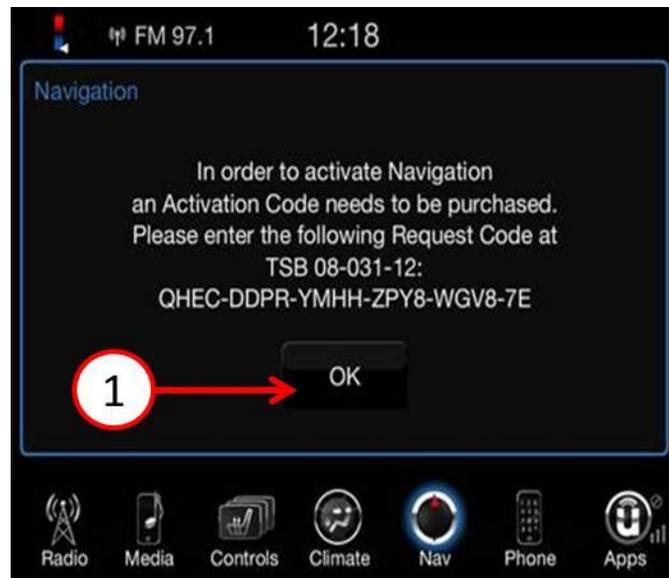
Fig. 3 To continue press OK

1 - Press "OK" to move to the next screen.

5. Take care to make sure the activation code is copied exactly as given because the activation code is case sensitive. Take the 16 position activation code back to the vehicle and press OK on the screen, see (Fig. 3).

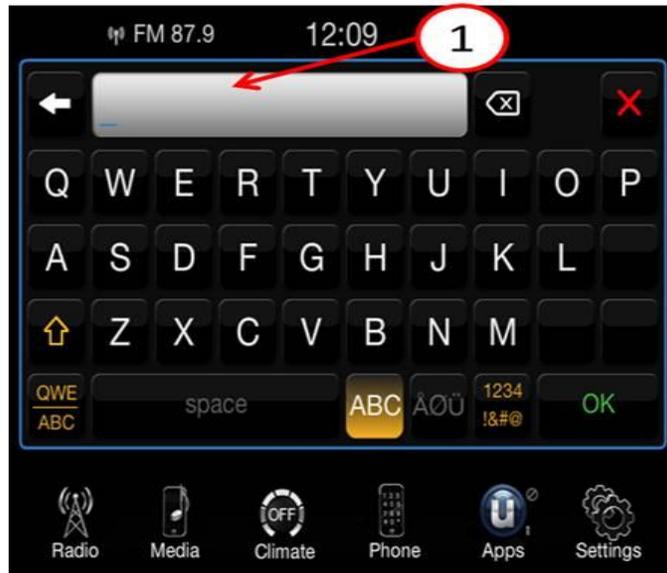
Fig. 4 Entering the VP3 code to activate navigation system

1 - Enter the Activation code in this space.

6. Enter the 16 position code in the box, do not use dashes. (Fig. 4).

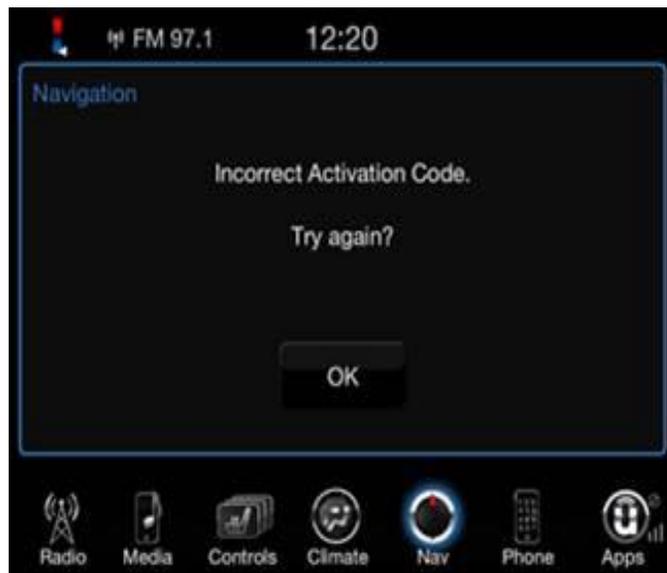
Fig. 5 Incorrect activation code was entered

8. If the access code was not properly copied or entered into the radio you will see this screen, (Fig. 5). If needed, start the procedure over again to enter the proper activation code.
