**NUMBER:** 08-062-15 REV. C

RA2, RG2 Radio Software Enhancements

2015 (BU) Jeep Renegade

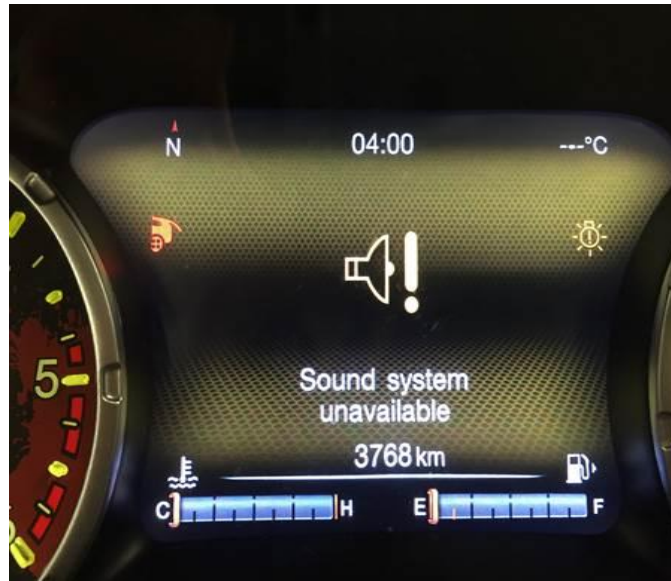
The customer may notice that blue tooth communication with the passenger is poor. If a passenger is trying to talk on the blue tooth phone, the caller will have a hard time understanding what the passenger is saying. The caller will not have any difficulty understanding the person in the driver's seat. Additionally a false message may be displayed in the Cluster; Parking Sensors Unavailable and/or Sound System Unavailable.

**Fig. 1 Message Displayed In The Cluster Sound System Unavailable**

**NOTE: \*\*If the above Icon/Message is displayed in the cluster, do NOT replace the speakers. Make sure the radio software is up to date.\*\***
