**NUMBER:** 18-021-15 REV. D

Flash: 3.0L Powertrain Diagnostic And System Enhancements

2014 (DS) RAM 1500 Pickup

**NOTE: This bulletin applies to vehicles equipped with a 3.0L Diesel Engine (Sales Code EXF).**

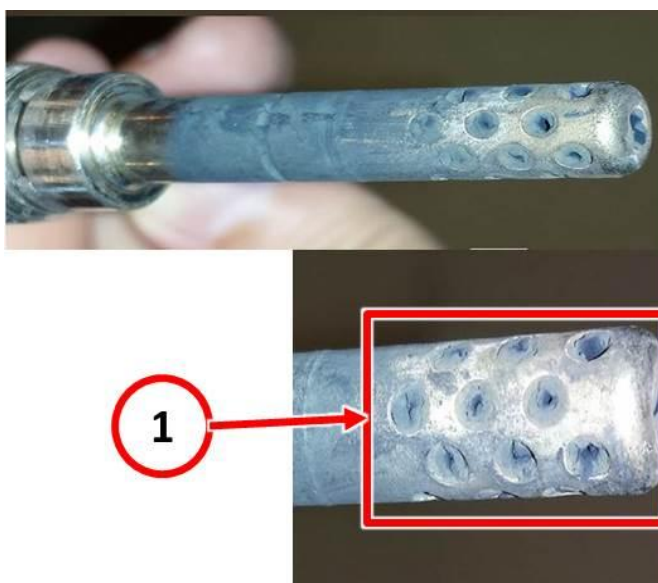
**Fig. 1 EGT Sensor Bank 1 Sensor 1**

11. Replace the O2 sensor. Refer to detailed repair procedures available in DealerCONNECT> TechCONNECT> Service Info Section 14 - Fuel System> Fuel Injection, Diesel> Sensor, Oxygen> Removal/Installation. Proceed to [Step #12](#).
12. Remove the EGT Sensor 1/2 located in the inlet of the Diesel Particulate Filter (DPF)/Diesel Oxidation Catalyst (DOC) assembly. Refer to detailed removal procedures available in DealerCONNECT> TechCONNECT> Service Info Section 11 - Exhaust System> Sensor, Exhaust Temperature> Removal> Exhaust Gas Temperature Sensor 1/2.
13. Inspect the sensor body and probe for any signs of damage or excessive soot. See ([Fig. 1](#)).

1 - Excessive soot blocking sensor ports

- 
14. Was excessive soot found on the sensor?
    - a. Yes>>> Proceed to [Step #15](#).
    - b. No>>> Proceed to [Step #16](#).
  15. Using shop air set to a maximum of 80 psi, clean all excessive soot from the sensor probe.
  16. Using a suitable multi-meter with appropriate test probes, test the resistance between the sensor connector terminals 1 and 2. With the sensor at room temperature, 65-75 °F (18-25 °C), the resistance should measure between 200 and 240 ohms.
