NUMBER: 08-055-15

GROUP: Electrical

DATE: May 16, 2015

RE2 RE3 RE6 RB4 RB5 RB6 Radio Enhancements

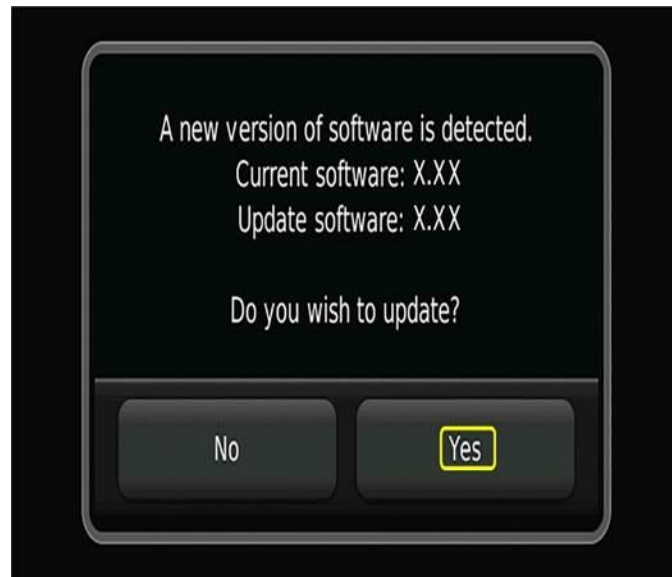
Fig. 2 Garmin software needs to be updated

16. Which screen does the radio display?
 - a. (Fig. 1) >>> The radio has the latest Garmin software in it, press OK and proceed to Step #20.
 - b. (Fig. 2) >>> Press Yes to update the Garmin software.
17. The first step in the update is “system recover”. There will be a pop up that indicates this step. This will only take a few minutes.
18. This screen will be displayed when the update is being downloaded, see (Fig. 3).

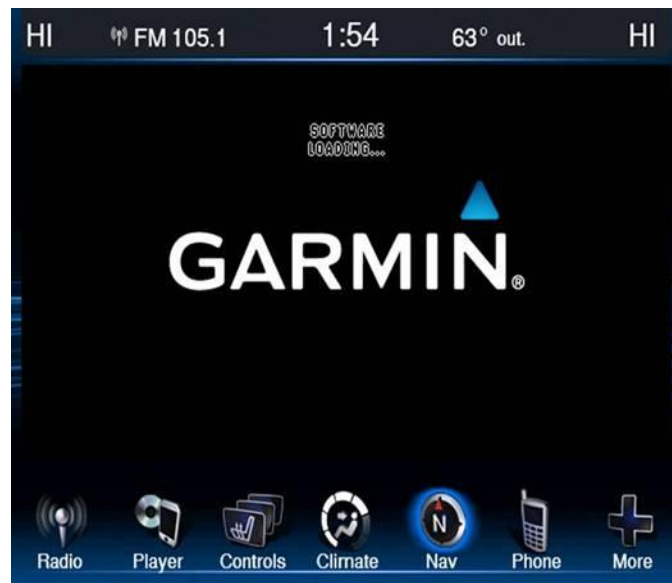
Fig. 3 This screen will be displayed next

1 - Loading software

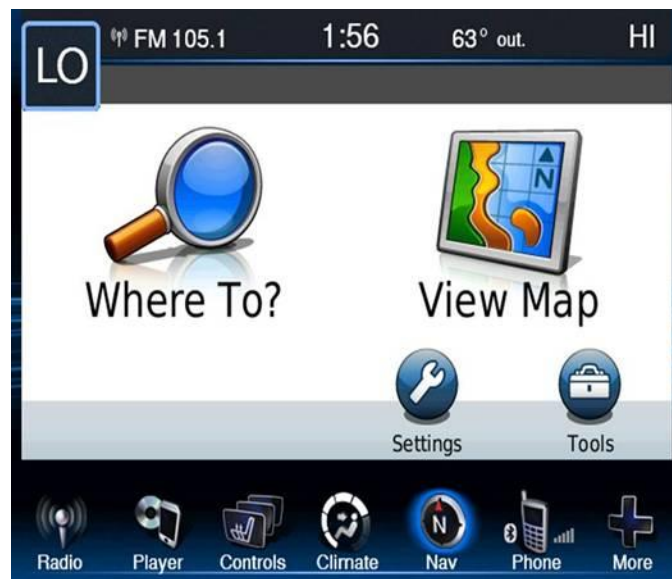
Fig. 4 Update is completed

1 - Navigation has been updated
