NUMBER: 07-004-15 REV. A

Malfunction Indicator Lamp (MIL) Illuminated DTC P1D73 Active Grill Shutter (AGS) Performance

This bulletin involves inspecting and securing the AGS actuator motor case housing.

2014 - 2015	(DS)	Ram 1500 Pickup
2015	(DX)	Ram 1500 Pickup (Mexico)

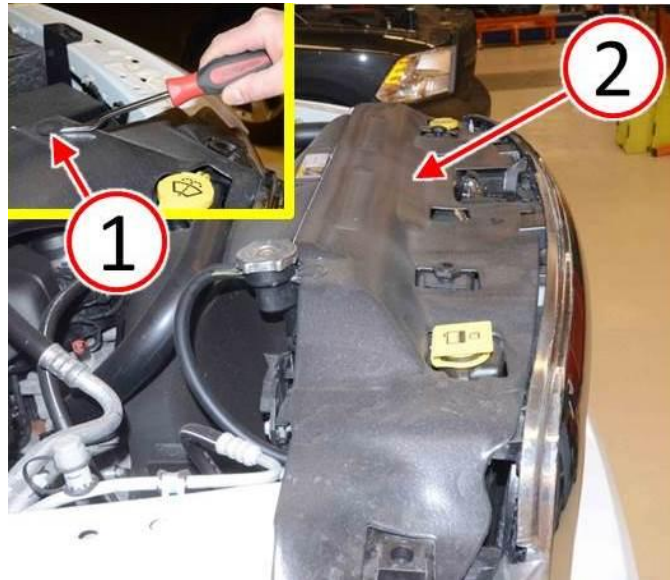
Fig. 1 Remove Upper Radiator Seal

1 - Push Pin Fasteners

2 - Upper Radiator Seal

1. Remove the six push pin fasteners (1) from upper radiator seal (Fig. 1).
2. Remove the upper radiator seal (2) (Fig. 1).

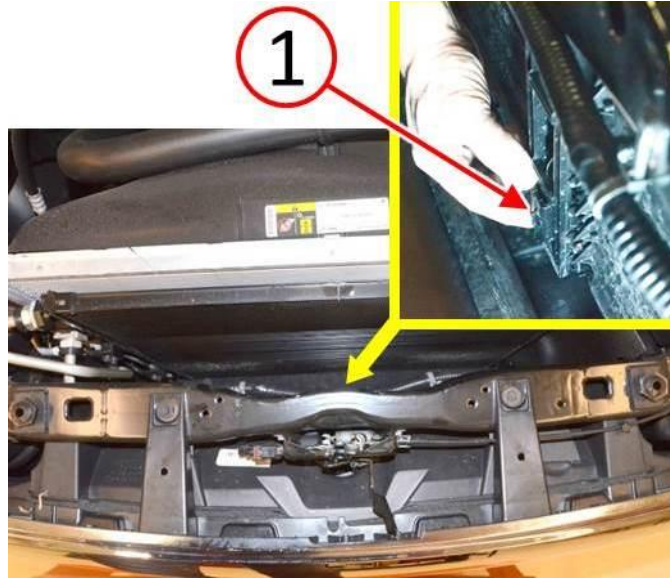
Fig. 2 Locate AGS Actuator Motor Case Housing

1 - Actuator Motor Case Housing

3. Locate the AGS actuator motor case housing (1) (Fig. 2).

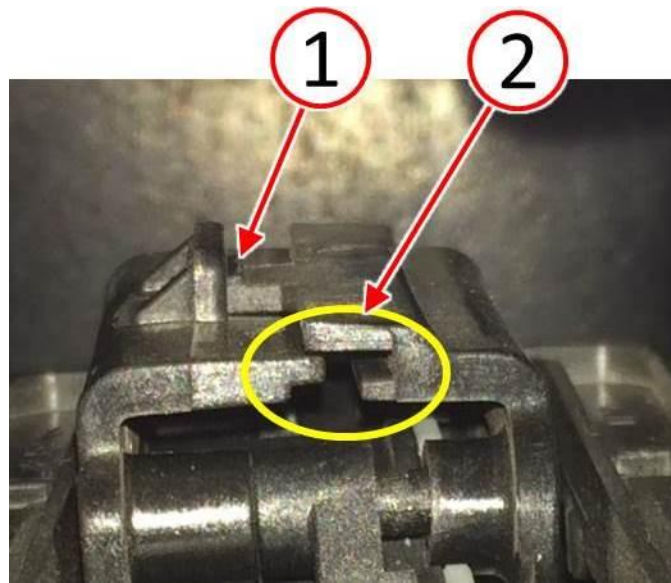
Fig. 3 Inspect Actuator Motor Case Housing For Separation

-
4. Inspect the AGS actuator motor case housing for unlocked retainer (1) and separation (2) of the actuator motor case housing halves (Fig. 3).
 5. Is an unlocked retainer (1) and/or housing separation (2) visible? As shown in (Fig. 3).
 - a. Yes >>> Proceed to [Step #8](#).
 - b. No >>> Continue to [Step #6](#).

- 1 - Retainer Unlocked
- 2 - Housing Separation

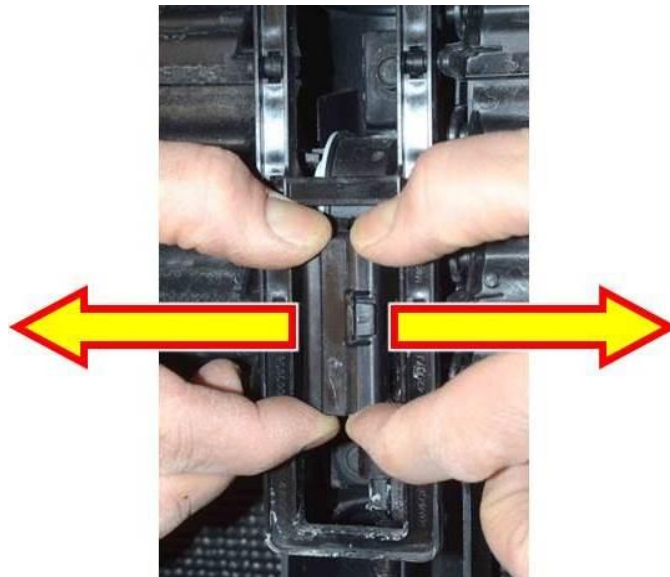
Fig. 4 Attempt To Separate Actuator Motor Case Housing Halves

-
6. Grasp both halves of the actuator housing and apply outward pressure while inspecting for any separation movement between the housing halves ([Fig. 4](#)).
 7. Was any movement or housing separation visible while applying outward pressure?
 - a. Yes >>> Continue to [Step #8](#).
 - b. No >>> This bulletin has been completed. Install the upper radiator seal and use LOP (23-02-01-95) to close the active RRT. If DTC P1D73 was present, normal diagnosis may need to be performed.

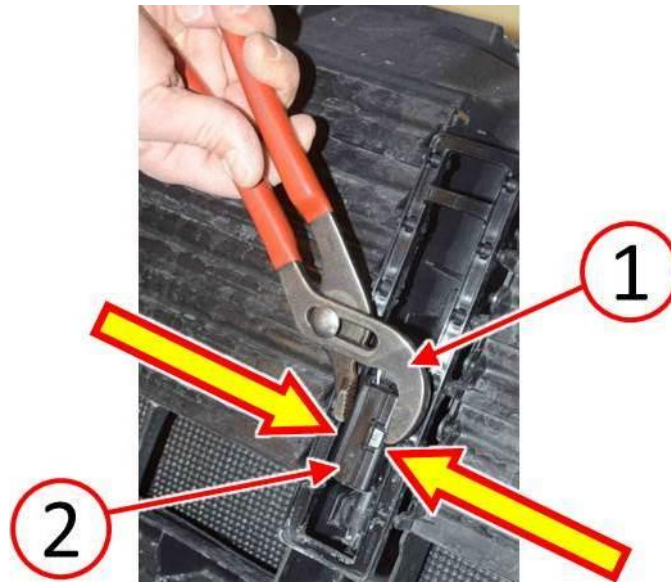
Fig. 5 Engage Actuator Motor Case Housing With Adjustable Pliers

- 1 - Adjustable Pliers
- 2 - Actuator Motor Case Housing

- Engage the actuator motor case housing retainer by using adjustable pliers to close the housing halves ([Fig. 5](#)).

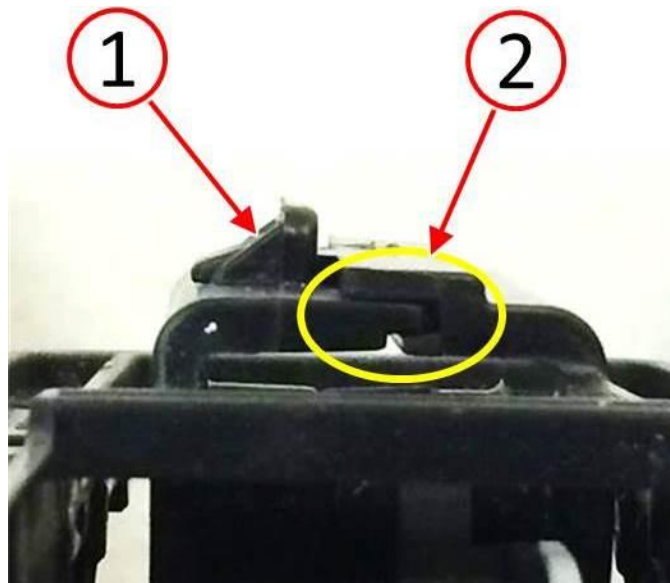
Fig. 6 Inspect Actuator Motor Case Housing For Engagement

-
- Inspect for engagement of the AGS actuator motor case housing retainer (1) and that no separation (2) is visible between the actuator motor case housing halves ([Fig. 6](#)).

- 1 - Retainer Locked
- 2 - Housing Halves Closed

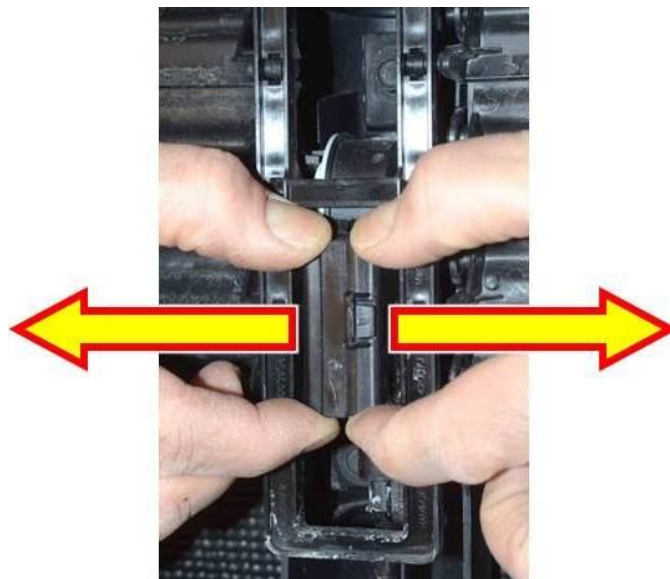
Fig. 7 Confirm Actuator Motor Case Housing Is Engaged

-
10. Grasp both halves of the actuator housing and apply outward pressure while inspecting for any separation movement between the housing halves ([Fig. 7](#)).
 11. Was any movement or housing separation visible while applying outward pressure?
 - a. Yes >>> Continue to [Step #12](#).
 - b. No >>> This bulletin has been completed. Install the upper radiator seal and use LOP (23-02-01-95) to close the active RRT. If DTC P1D73 was present, clear the DTC and check the AGS for proper operation.

- 12. Repeat [Step #8](#) through [Step #11](#). If the AGS actuator motor case housing retainer fails to lock after repeated attempts, continue to [Step #13](#).
- 13. Replace the AGS assembly and clear any DTCs that may have been set. Refer to the detailed service procedures available in DealerCONNECT> TechCONNECT under: Service Info> 23 - Body> Exterior> GRILLE, Active Shutter> Removal/Installation.
