NUMBER: 18-021-15 REV. A

Flash: 3.0L Powertrain Diagnostic And System Enhancements

2014 (DS) RAM 1500 Pickup

NOTE: This bulletin applies to vehicles equipped with a 3.0L diesel engine (sales code EXF).

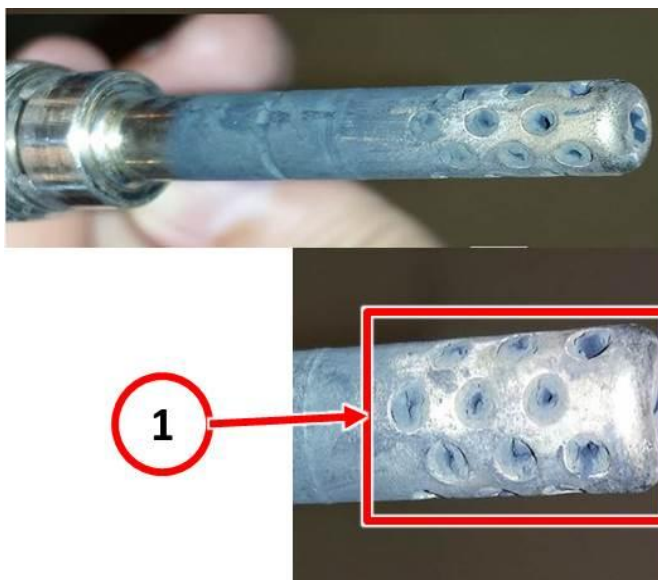
Fig. 1 EGT Sensor Bank 1 Sensor 1

9. Replace the O2 sensor. Refer to detailed repair procedures available in DealerCONNECT> TechCONNECT> Service Info Section 14 - Fuel System> Fuel Injection, Diesel> Sensor, Oxygen> Removal/Installation. Proceed to [Step #10](#).
10. Remove the EGT Sensor 1/2 located in the inlet of the Diesel Particulate Filter (DPF)/Diesel Oxidation Catalyst (DOC) assembly. Refer to detailed removal procedures available in DealerCONNECT> TechCONNECT> Service Info Section 11 - Exhaust System> Sensor, Exhaust Temperature> Removal> Exhaust Gas Temperature Sensor 1/2.
11. Inspect the sensor body and probe for any signs of damage or excessive soot. See ([Fig. 1](#)).

1 - Excessive soot blocking sensor ports

-
12. Was excessive soot found on the sensor?
 - a. Yes>>> Proceed to [Step #13](#).
 - b. No>>> Proceed to [Step #14](#).
 13. Using shop air set to a maximum of 80 psi, clean all excessive soot from the sensor probe.

14. Using a suitable multi-meter with appropriate test probes, test the resistance between the sensor connector terminals 1 and 2. With the sensor at room temperature, 65-75 °F (18-25 °C), the resistance should measure between 200 and 240 ohms.
15. Is the temperature sensor resistance within specifications?
 - a. Yes>>> Install the original EGT sensor 1/2. Refer to detailed installation procedures available in DealerCONNECT> TechCONNECT> Service Info Section 11 - Exhaust System> Sensor, Exhaust Temperature> Installation> Exhaust Gas Temperature Sensor 1/2.
 - b. No>>> Install a new EGT sensor 1/2. Refer to detailed installation procedures available in DealerCONNECT> TechCONNECT> Service Info Section 11 - Exhaust System> Sensor, Exhaust Temperature> Installation> Exhaust Gas Temperature Sensor 1/2.
16. Verify all engine systems are operating as designed. The bulletin is now complete.
