NUMBER: 08-033-15 REV. A

Flash: RE2 RE3 RE4 RE6 RE7 RB4 RB5 RB6 RB4 Radio Enhancements

This bulletin involves updating the radio control head software and navigation if equipped.

2013-2014	(LD)	Dodge Charger
2013-2014	(LX)	Chrysler 300
2013-2015	(JC)	Dodge Journey

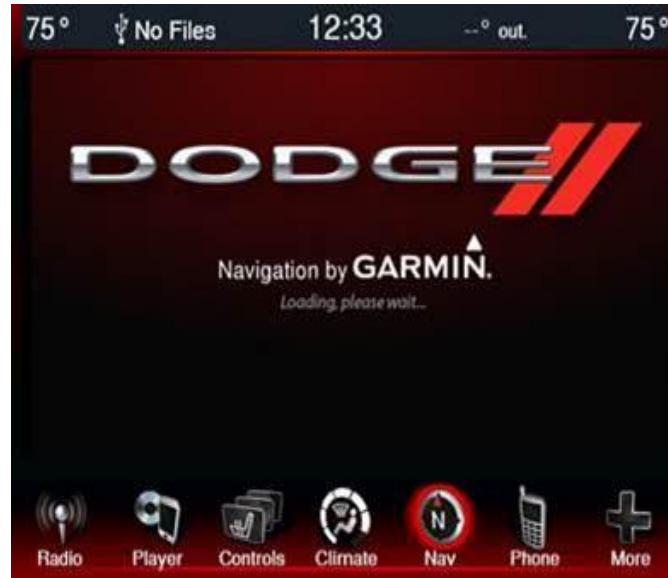
Fig. 1 System Loading Screen

3. Press the navigation screen button and attempt to access the navigation main menu system.
4. Is the radio stuck on the “Loading Please Wait” screen? See ([Fig. 1](#)).

- a. Yes >>> The radio will have to be replaced. Replace the radio using current electronic exchange center stock following normal warranty repair procedures. Refer to published service information in Tech Connect Section 08 - Electrical/8E - Electronic Control Modules/MODULE, Telematics Gateway/Removal. No further action is required, the bulletin is now complete. The replacement radio will contain the latest software update.
- b. No >>> Proceed to [Step #5](#) and perform the software update.

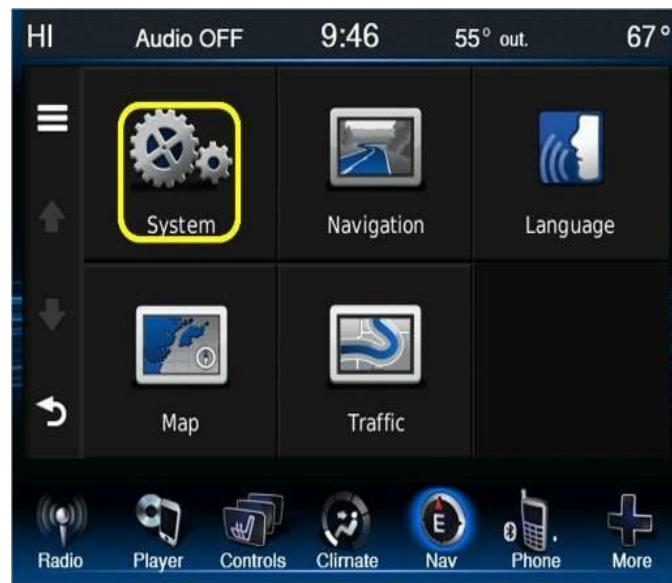
Fig. 4 System Icon

18. Press the System Icon. See ([Fig. 4](#)).

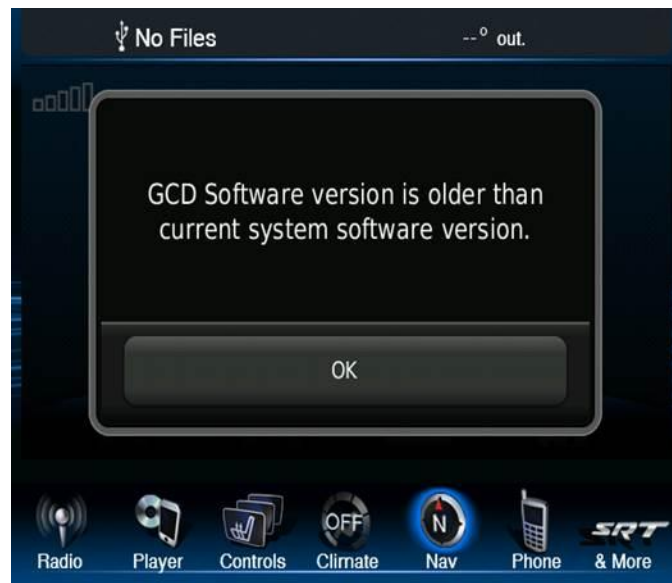
Fig. 6 Garmin Software Already Updated

23. Which screen does the radio currently display?
 - a. (Fig. 6) >>>The radio has the latest Garmin software installed. Press OK and proceed to [Step #27](#).
 - b. (Fig. 7) >>>Press Yes to continue and proceed with the Garmin software update, proceed to [Step #24](#).
24. The first step in the update is “system recover”. There will be a pop up that indicates this step along with a progress bar. This will only take a few minutes.
25. This next screen will be displayed when the update is being down loaded, see ([Fig. 8](#)).

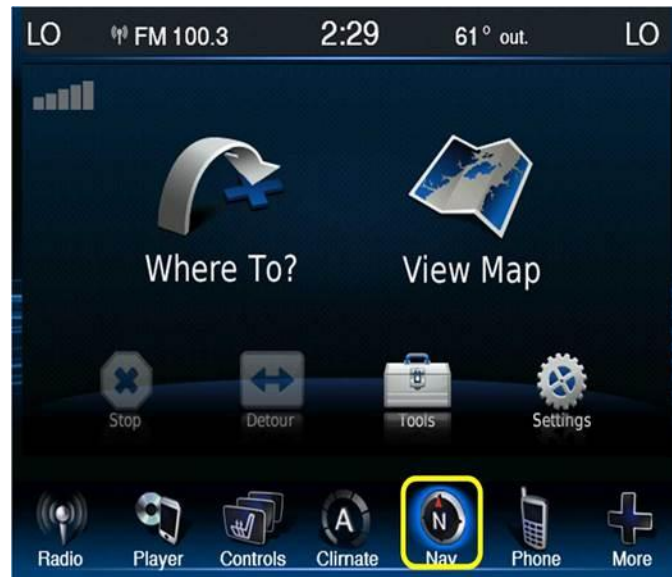
Fig. 9 Update Complete

26. When the software has completed down loading, the screen will change to the Garmin main screen, see (Fig. 9).

27. Remove the USB flash drive and cycle the key. The bulletin is now complete.
