NUMBER: 23-031-15

Gap Between Headliner And Sunroof Shade

2015 (KL) Jeep Cherokee

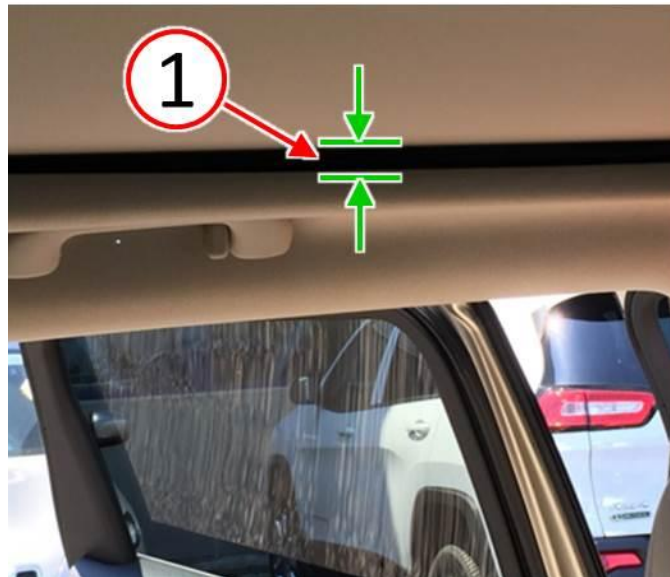
Fig. 1 Gap Between Headliner And Sunroof Shade

The customer may describe a larger than expected gap between the headliner and the sunroof shade.

1. Measure the gap (1) between the sunroof shade and the headliner (Fig. 1).

1 - Gap

2. Is the gap greater than 4 mm (5/32 in.)?
 - a. YES>>> Continue with the Repair Procedure [Step #3](#).
 - b. NO>>> This bulletin has been completed, use LOP (23-20-45-9D) to close the active RRT.
3. Replace the headliner. Refer to the detailed service procedures available in DealerCONNECT> TechCONNECT under: Service Info> 23 - Body> Interior> HEADLINER> Removal/Installation.
