NUMBER: 08-055-15 REV. A

GROUP: Electrical

RE2 RE3 RE6 RB4 RB5 RB6 Radio Enhancements

OVERVIEW:

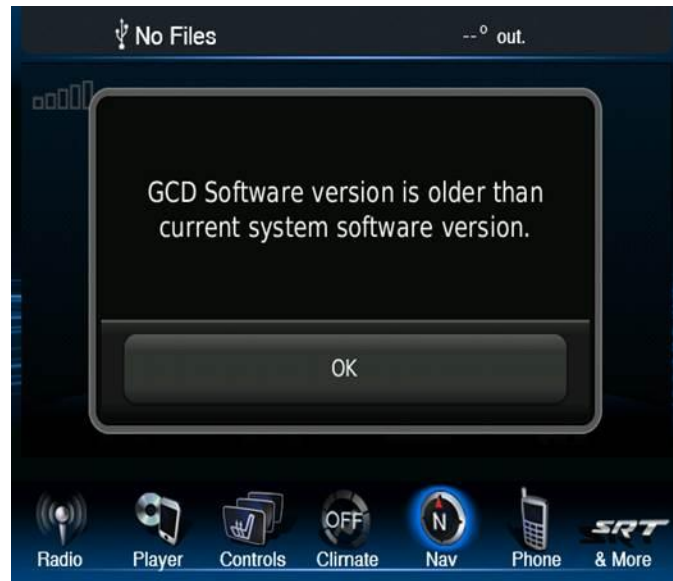
Fig. 1 Radio already has the latest software

16. Which screen does the radio display?
 - a. (Fig. 1) >>> The radio has the latest Garmin software in it, press OK and proceed to [Step #20](#).
 - b. (Fig. 2) >>> Press Yes to update the Garmin software.
17. The first step in the update is "system recover". There will be a pop up that indicates this step. This will only take a few minutes.
18. This screen will be displayed when the update is being downloaded, see (Fig. 3).

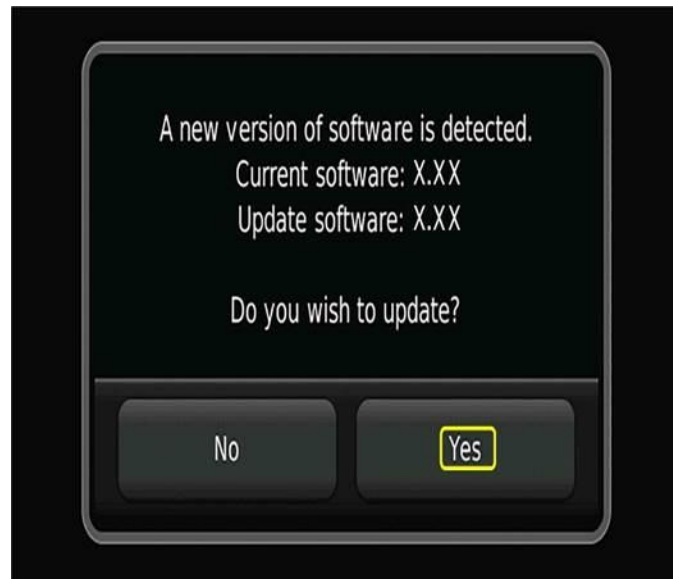
Fig. 2 Garmin software needs to be updated

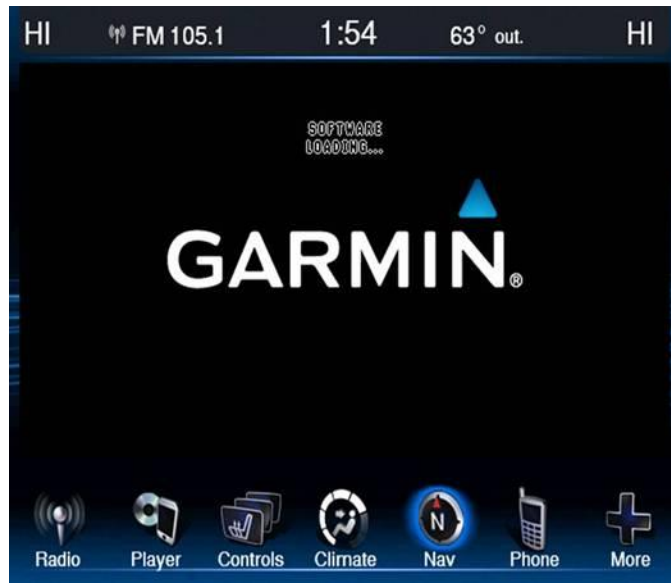
Fig. 3 This screen will be displayed next

1 - Loading software
