NUMBER: 19-003-15

GROUP: Steering

Intermittent Power Steering Noise And/Or Slight Loss Of Assist

2015 (LA) Dodge Challenger

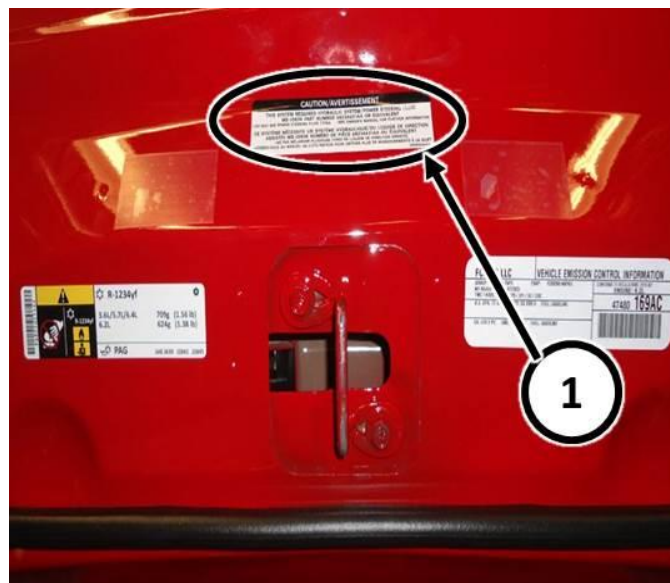
Fig. 1 Underhood View

1 - Power steering label installation location.

5. Install the low pressure return line and tighten to 38 nm (28 ft lb).
6. Install the belly pan. Refer to the detailed service procedures available in DealerCONNECT/TechCONNECT Service Info section 13 - Frame and Bumpers> Under Body Protection> BELLY PAN, Engine> Installation.
7. Fill the system with the specified MS-10838 (pn# 68234631AA) fluid and bleed the system of all air. Refer to the detailed service procedures available in DealerCONNECT/TechCONNECT Service Info section 19 - Steering> Standard Procedure> Power Steering System Bleeding.
8. Install the new power steering caution label under hood. Refer to (Fig. 1).
