**NUMBER:** 07-005-15 REV. A

Intermittent Coolant Weepage From Upper Radiator Hose

2015	(LA)	Dodge Challenger
<b>**2015</b>	<b>(LD)</b>	<b>Dodge Charger**</b>

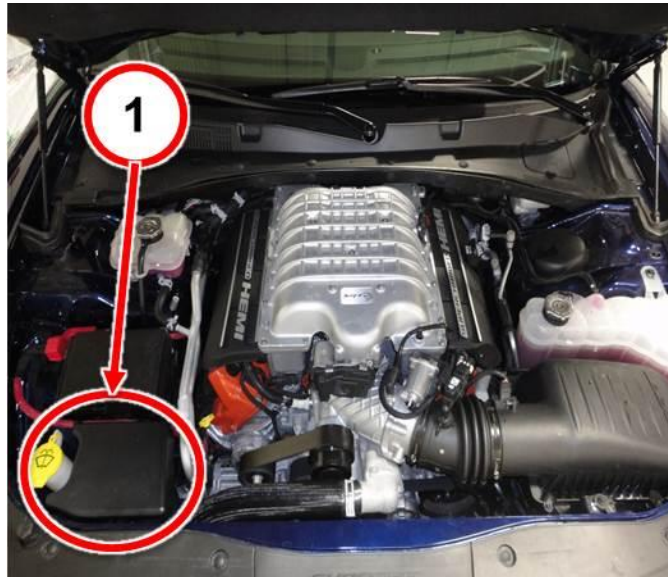
**Fig. 1 Underhood View**

1 - ABS Module Impact Cover

1. Raise the hood.
2. If equipped, remove the impact cover located above the ABS module, See (Fig. 1), by removing the 2 push pin retainers located between the cover and the Power Distribution Center (PDC) and then sliding the cover rearward.

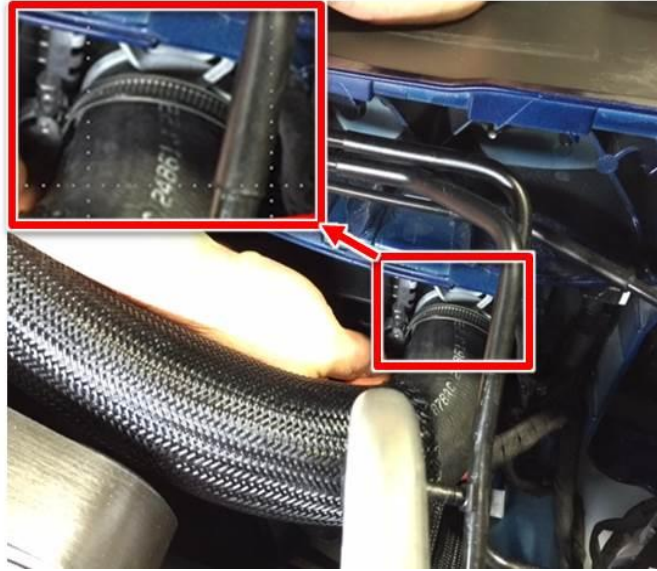
***Fig. 2 Radiator Hose Clamp Orientation***

A small number of customers may experience a slight coolant weepage underhood. After further inspection, the technician may notice coolant weeping from the upper radiator hose connection at the radiator.

- 
3. Inspect the upper radiator hose and verify it is properly seated onto the radiator. The end of the hose should be tight against the stop molded onto the radiator.
  4. Open the new clamp and place it over the radiator hose. The hex head of the clamp should be facing up and be oriented on the core side of the radiator. See (Fig. 2).

**NOTE:** When installing the new clamp, the original will remain in place. The new clamp should be positioned between the existing clamp and the radiator outlet flange. Take care not to overlap the clamps.

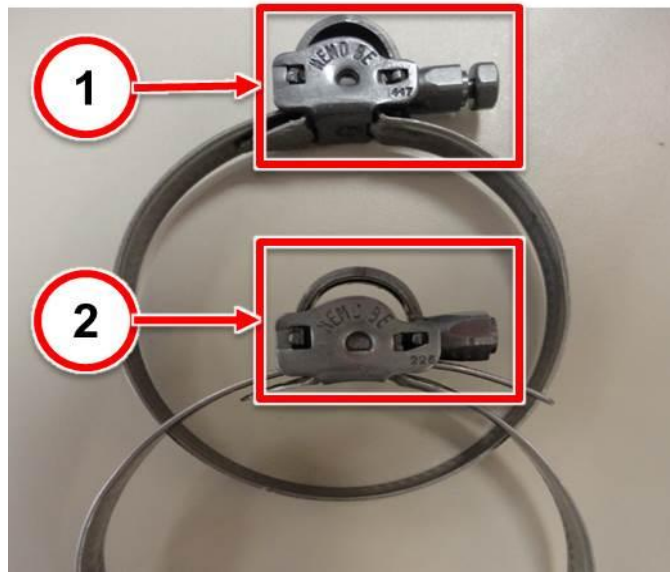
**Fig. 3 Hose Clamp Torque Limiting Head**

1 - Before tightening

2 - After tightening

**NOTE:** The new clamp will have a torque limiting head. The head will break free once proper torque of 3 nm (26 in lb) is achieved. Care must be taken to ensure the socket used only engages the head of the bolt to prevent over tightening the clamp.

5. Using a 7mm shallow socket and swivel, tighten the new clamp until the torque limiting head breaks free. See (Fig. 3).
