**NUMBER:** 13-001-15

Right Front Side Rail Inner Panel Stamping Deformity

2015                      (JC)                                      Dodge Journey

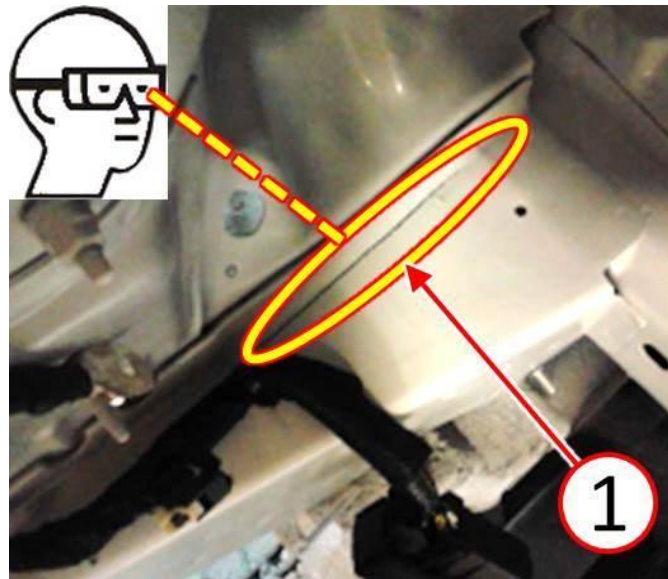
**Fig. 2 Inspect Right Front Side Rail Inner Panel For Deformities**

The right front side rail inner panel may have visible deformities created during the stamping process.

2. Push aside wire harness that hides the top of the right front side rail inner panel from view.
3. Inspect right front side rail inner panel for any cracks or splits (1) as shown in (Fig. 2).

- 4. Were any cracks or splits found in the right front side rail inner panel?
  - a. YES>>> Contact your Area Manager or Business Center Customer Relations/Warranty Manager for buy back instructions and perform [Step #5](#).
  - b. NO>>> This bulletin does not apply. Perform [Step #5](#).
- 5. Reposition wire harnesses and install the engine cover.
