NUMBER: 09-003-15

GROUP: Engine

Incorrect Bolt Length Used For Fastening Transmission To Engine

Chrysler 200

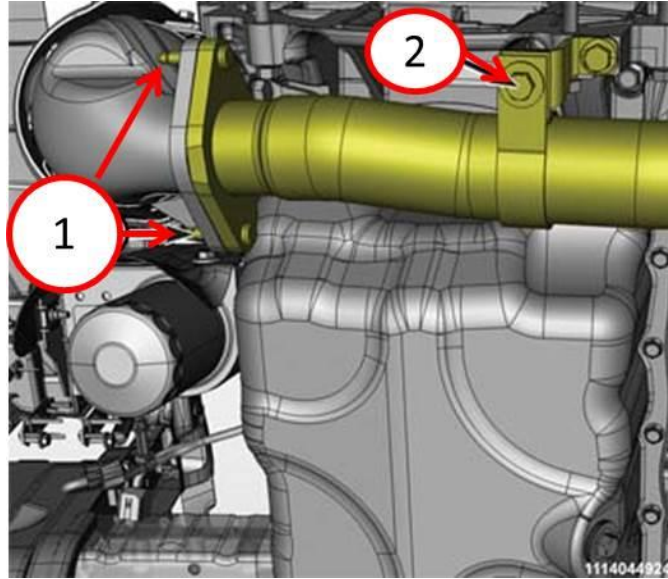
Fig. 2 Crossunder Pipe

- 1 - Flange Nuts
 - 2 - Support Bolt
-

3. Remove and discard the nuts (1) from the exhaust flange at the cross under pipe at catalytic converter outlet flange (Fig. 2).
4. Remove and discard the exhaust flange gasket.
5. Remove and save the bolt (2) from the exhaust bracket securing the cross under pipe (Fig. 2).
6. Position aside the cross under pipe and secure with a strap or equivalent item.

-
9. Reinstall the exhaust cross under pipe to the catalytic converter outlet flange and install a new exhaust flange gasket.
 10. Install new nuts (1) to the exhaust flange at the cross under pipe (Fig. 2). Tighten to 25 N·m (18 ft.lbs).
 11. Reinstall the bolt (2) to the exhaust bracket securing the cross under pipe (Fig. 2). Tighten to 25 N·m (18 ft.lbs).
 12. Reinstall the engine belly pan and bolts (Fig. 1). Tighten to 6 N·m (53 in.lbs).
 13. Lower vehicle on hoist.

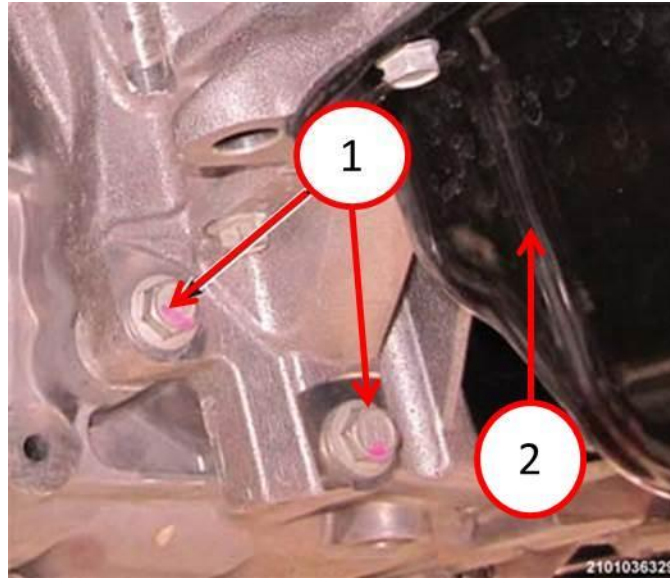
Fig. 3 Two Bolts To Be Replaced

- 1 - Bolts
- 2 - Oil Pan

7. Remove and discard the 2 bolts (1) holding the engine block to the bell housing next to the differential housing, located directly below the starter at the front of the engine. (Fig. 3).
8. Install the new 45mm bolts in place of the bolts removed (Fig. 3). Tighten to 50 N·m (36 ft.lbs).
