NUMBER: 18-054-15

Mil Illumination: P2453,P2454,P2455 or P2463 Active or Stored

This bulletin involves determining if the Differential Pressure Sensor and its Connector require repair.

2010-2015 (RT) Chrysler Town And Country (International Only)

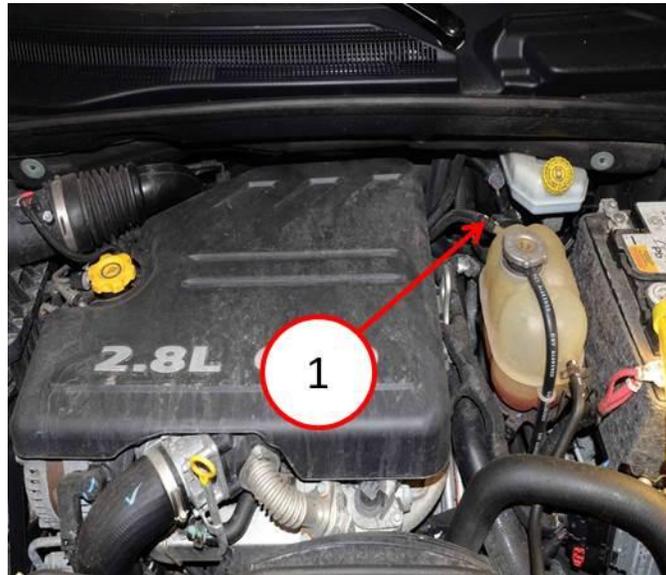
Fig. 1 Differential Pressure Sensor Location - Engine Compartment Location

1 -Differential Pressure Sensor Location

1. Disconnect the negative battery terminal.
2. Disconnect the Coolant Bottle and reposition it to reach the Differential Pressure Sensor (DPS) ([Fig. 1](#)).

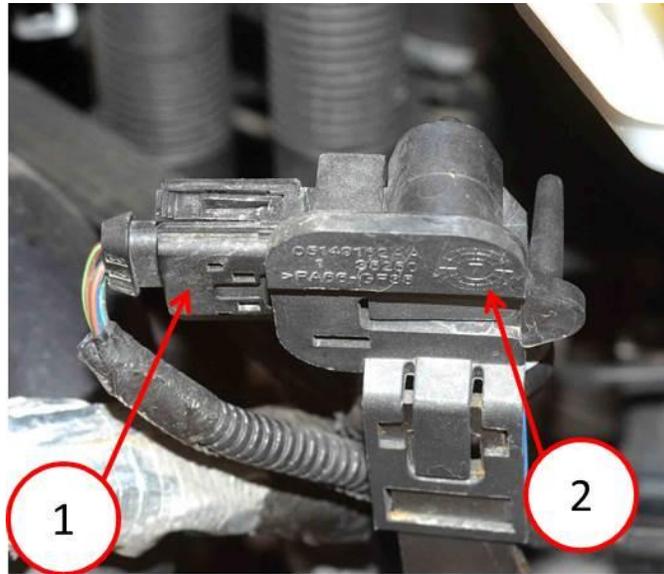
Fig. 2 Differential Pressure Sensor

- 1 - Differential Pressure Sensor Harness Connector
- 2 - Differential Pressure Sensor

-
4. Are the terminals oxidized/ corroded ?
 - a. Yes. >>> Proceed with [Step #5](#).
 - b. No. >>> This bulletin does not apply. Normal Diagnostics should be performed.

NOTE: Normal inspection methods may not uncover the type of corrosion present (fretting).

3. Disconnect the differential pressure sensor harness connector and check for oxidation ([Fig. 2](#)).

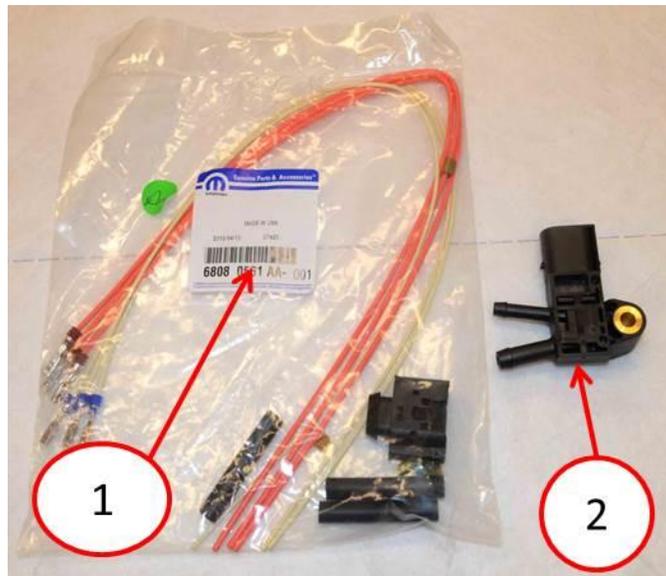
Fig. 3 Parts Required

- 1 - P/N 68080561AA - Wiring Kit
- 2 - P/N 56044587AB - Sensor

5. Disconnect the differential pressure sensor hoses.
6. Release the clips and remove the differential pressure sensor.
7. Using the Wiring Kit, P/N 68080561AA ([Fig. 3](#)), replace the existing 3 way connector and terminals with the new components from the kit which will be complete with silver plated terminals. To complete the Service Procedure only the white wires are necessary. Refer to the detailed service procedures available in DealerCONNECT> TechCONNECT under: Service Info>29- Non DTC- Diagnostic>Circuit Testing Procedures>Standard Procedure>Wire Splicing.
