This Service Information bulletin supersedes SI B11 13 15 **dated July 2015**.

SUBJECT

Service Action: N20 Engine - Inspect and Replace Engine Oil Filter Housing

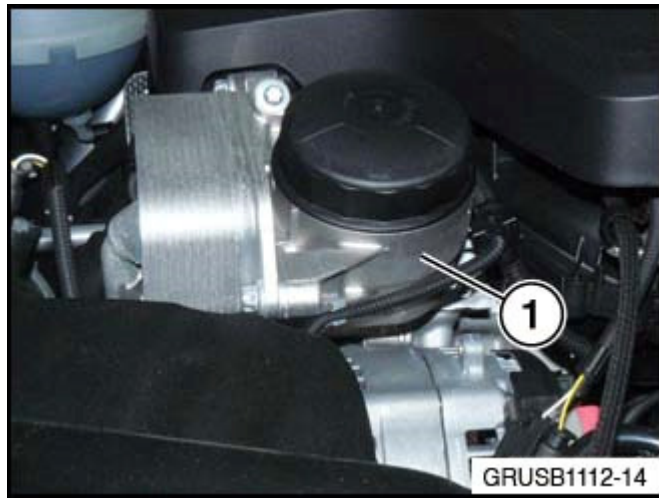
2. If the vehicle is fitted with the aluminum oil filter housing (silver color) then take no further action. Do not replace any parts.

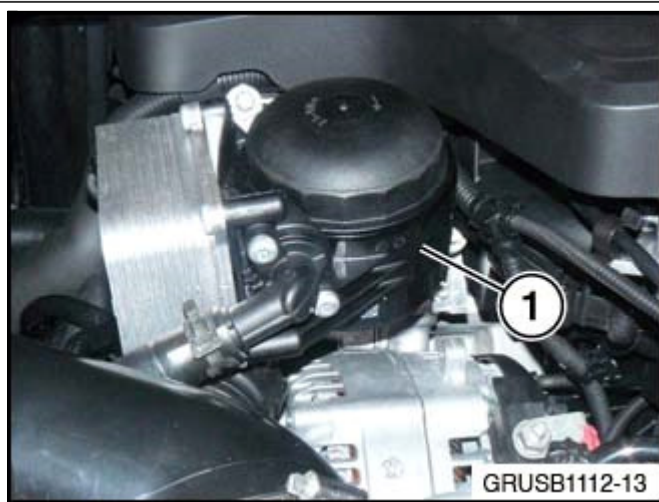
The plastic oil filter housing may fail and lead to an internal and/or external engine oil or coolant leak.

3. If the vehicle is fitted with the plastic engine oil filter housing (black color) then replace the engine oil filter housing as per the attached instructions.
