NUMBER: 18-023-15 REV.C

Flash: 3.0 L MIL Illumination Diagnostic and System Improvements

2014 (WK) Jeep Grand Cherokee

NOTE: This bulletin applies to vehicles equipped with a 3.0L diesel engine (sales code EXF).

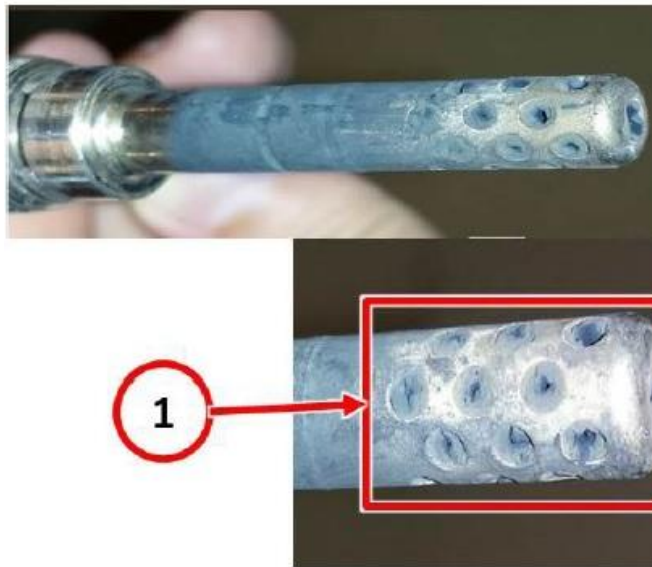
Fig. 1 EGT Sensor Bank 1 Sensor 1

11. Inspect the sensor body and probe for any signs of damage or excessive soot. See (Fig. 1).

1 - Excessive soot blocking sensor ports

-
12. Was excessive soot found on the sensor?
- a. Yes>>> Proceed to [Step #13](#).
 - b. No>>> Proceed to [Step #14](#).
13. Using shop air set to a maximum of 80 psi, clean all excessive soot from the sensor probe.

14. Using a suitable multi-meter with appropriate test probes, test the resistance between the sensor connector terminals 1 and 2. With the sensor at room temperature, 65-75 °F (18-25 °C), the resistance should measure between 200 and 240 ohms.

15. Is the temperature sensor resistance within specifications?
- a. Yes>>> Install the original EGT sensor 1/2 and/or Catalyst Temperature Sensor. Refer to detailed installation procedures available in DealerCONNECT> TechCONNECT> Service Info Section 11 - Exhaust System> Sensor, Exhaust Temperature> Installation> Exhaust Gas Temperature Sensor 1/2.

- b. No>>> Install a new EGT sensor 1/2 and/or Catalyst Temperature Sensor. Refer to detailed installation procedures available in DealerCONNECT> TechCONNECT> Service Info Section 11 - Exhaust System> Sensor, Exhaust Temperature> Installation> Exhaust Gas Temperature Sensor 1/2.
