NUMBER: 08-096-15

Splash Screen Displays Incorrect Logo In The Electronic Vehicle Information Center (EVIC)

2016 (DS) Ram 1500 Pickup

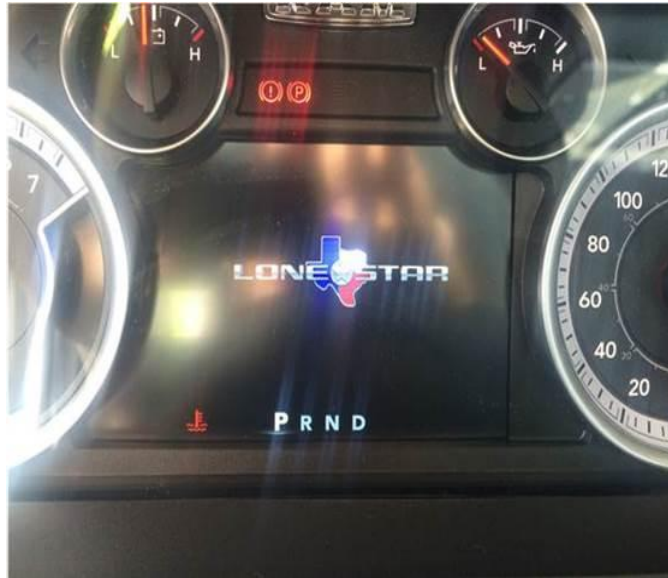
The customer may notice the splash screen is incorrectly displaying a Lonestar logo (Fig. 1) in the Electronic Vehicle Information Center (EVIC) when the vehicle is first started and it should be displaying the Big Horn logo (Fig. 2).

Fig. 1 Lone Star Splash Screen

1. Using wiTECH, reconfigure the vehicle. This routine is available under the 'Diagnostic Procedures' tab found on the home, 'Vehicle View', page of wiTECH.

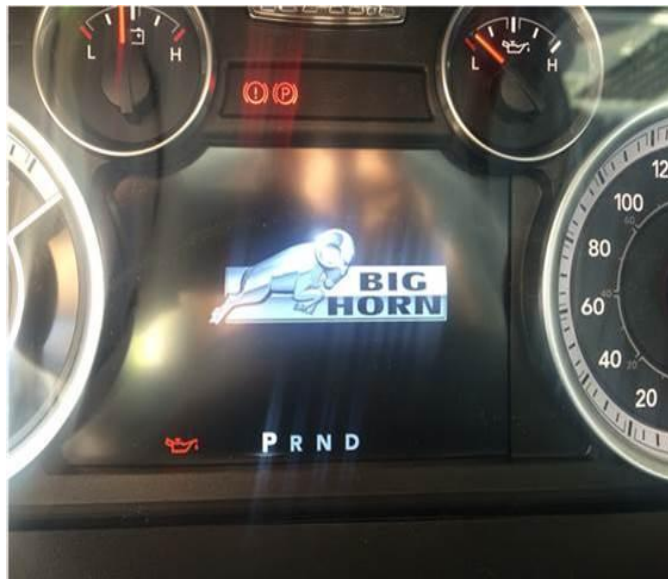
Fig. 2 Big Horn Splash Screen
