NUMBER: 08-098-15

Hands Free Feature Inoperative

This bulletin involves updating the Convergence Telematics Module (CTM) software.

****Dodge**** Dart

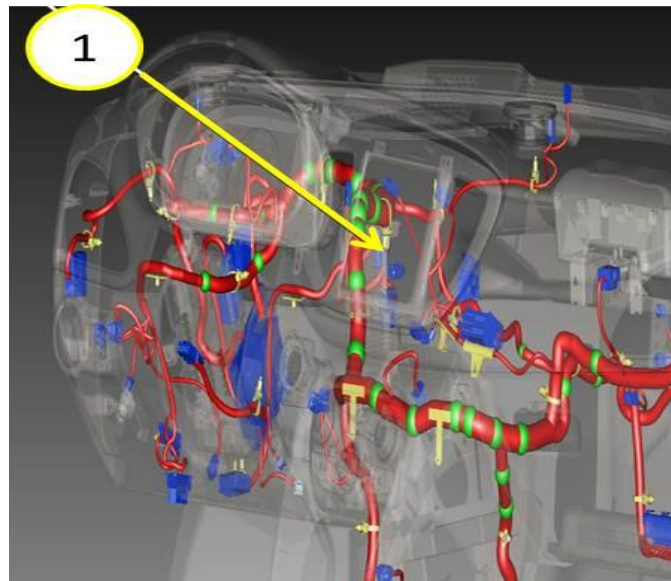
Fig. 2 CTM Location Under The Dash

1 - CTM location

18. ****Does this vehicle have a remote USB port (sales code RSX)?**
 - a. Yes >>> Proceed to [Step #21](#).
 - b. No >>> Proceed to [Step #19](#).
19. Gain access to the CTM, refer to TechConnect > Electrical/8E - Electronic Control Modules/MODULE, Convergence Telematics/Removal, CTM location see ([Fig. 2](#)).
