2nd Row Tip-Up Style Seat Lower Cushion Excessive Movement (8-Passenger Vehicle Only)

YEAR(S)	MODEL(S)	ADDITIONAL INFORMATION
2011 - 2015	Sienna

The information contained in this bulletin supersedes SB No. T-SB-0180-12.

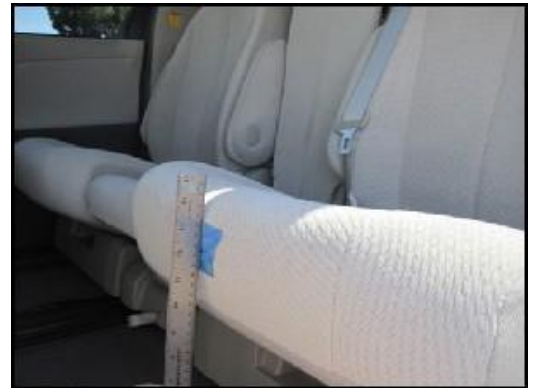
Figure 1. Example of Seat Measurement

2. While applying pressure, measure the amount of movement in the lower cushion assembly.
 - A. Apply tape to the front edge of the cushion.
 - B. Draw a reference line on the tape.
 - C. Measure vertical movement of the lower cushion.

Ensure that no seat cushion foam deformation occurs at the end of cushion in order to have a more accurate measurement of actual play.

MEASUREMENT	INSPECTION RESULT	REPAIR	OP CODE
0 – 10 mm	Normal Characteristic (within specification)	None	None
10+ mm	Excessive Movement	Perform Repair Method Based on VIN Range	Use OP CODE Based on VIN Range

1. **VIN Range "A"** – Replace the No. 1 Seat Leg Sub-assembly, LH and the No. 1 Seat Cushion Frame Sub-assembly.

VIN Range "B" – Replace the No. 1 Seat Leg Sub-assembly, LH.
