TT7484EN, Rev. A
February, 2015
Page 1 of 3

SUBJECT: Inability to Check Oil Level via Pushbutton Shift Selector on Kenworth and Peterbilt Trucks

MODELS AFFECTED: 3000 Series and 4000 Series Product Family Transmissions

VOCATIONS AFFECTED: Kenworth Models T680 and T880 and Peterbilt Models 579 and 567

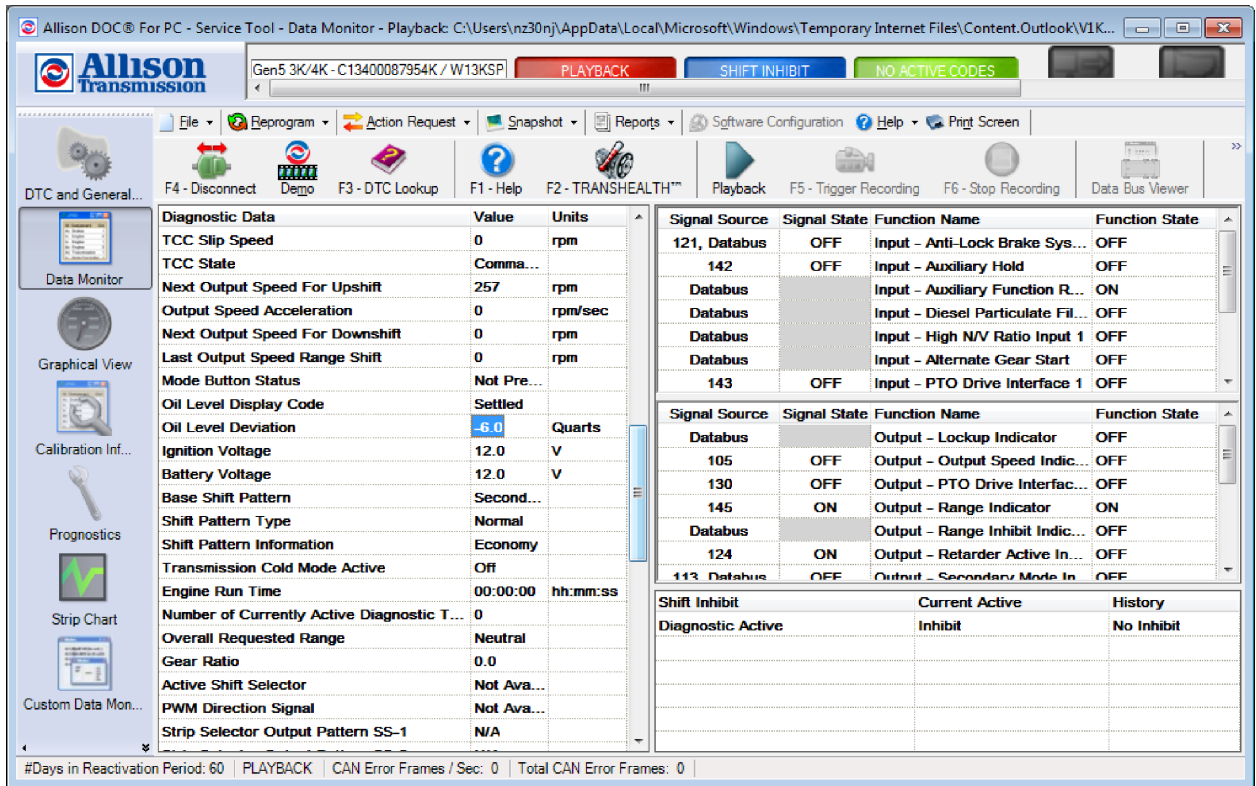
Figure 1. Oil Level Deviation Reading

The Kenworth and Peterbilt models listed above have been built without a wire for the oil level sensor (OLS) in a portion of the OEM harness. Wire 116 may be present from the transmission to a bulkhead connector, but it may be missing on the other side of the bulkhead.

- Inability to check oil level using the Pushbutton Shift Selector (skips to Prognostics).
- Very low (e.g. -6.0 Quarts) or no oil reading for "Oil Level Deviation" in the Data Monitor tab of the Universal Allison DOC® service tool. Refer to [Figure 1](#).

NOTE: After Wire 116 is added to correct the oil level display issue, the oil level sensor auto-detect must be reset using the "Reset Auto-Detect Oil Level Sensor" feature in Universal Allison DOC® "Action Requests" menu for 5th Gen Controls, or "Reset Auto-Detect" for 4th Gen Controls.

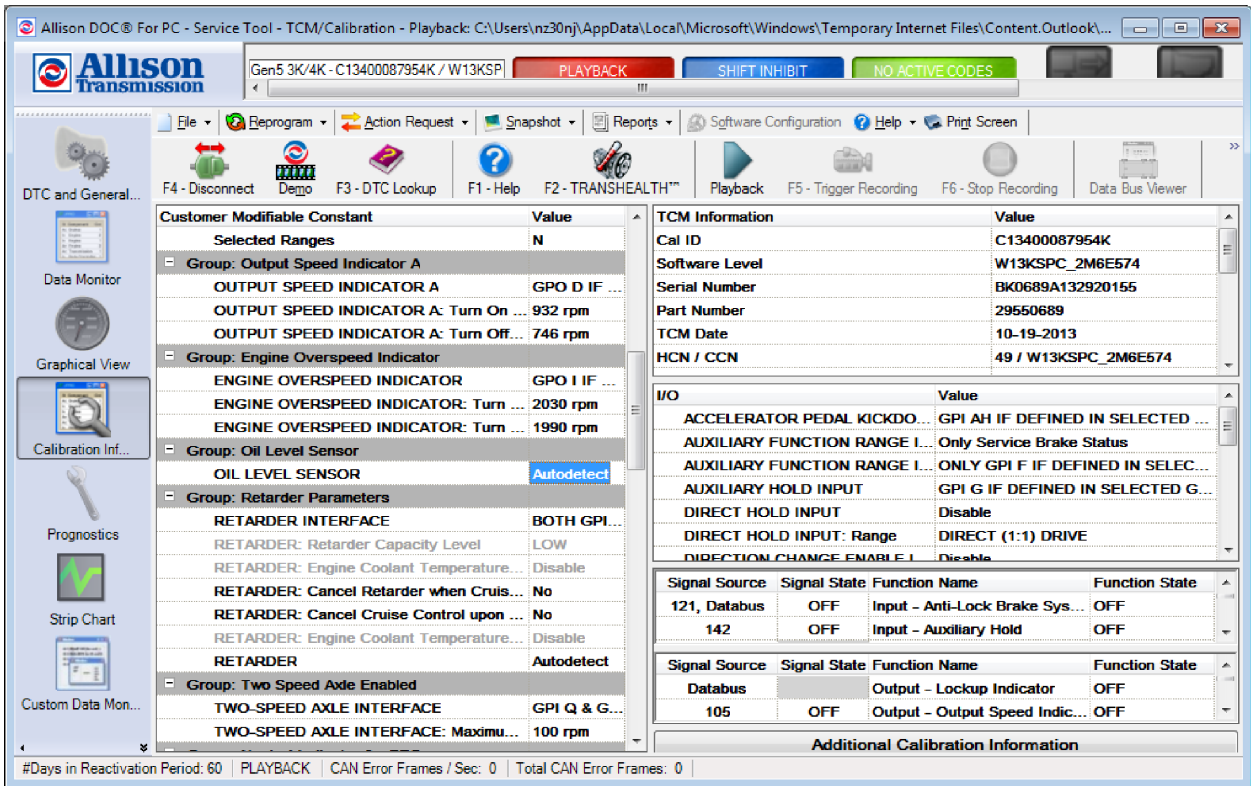
Figure 2. Oil Level Sensor Parameter

NOTE: When viewing the Calibration Information screen in the Universal Allison DOC® service tool software, the OIL LEVEL SENSOR parameter will still show “AUTODETECT”. Refer to [Figure 2](#).
