TT7693EN  
August, 2015  
Page 1 of 8

SUBJECT: C3/C4 Bonded Piston P/N 29552373 Failure – Capture of Relevant Information

MODELS AFFECTED: 3000, 3500 Models (All Variants), B300, B400, T Series (All Variants)

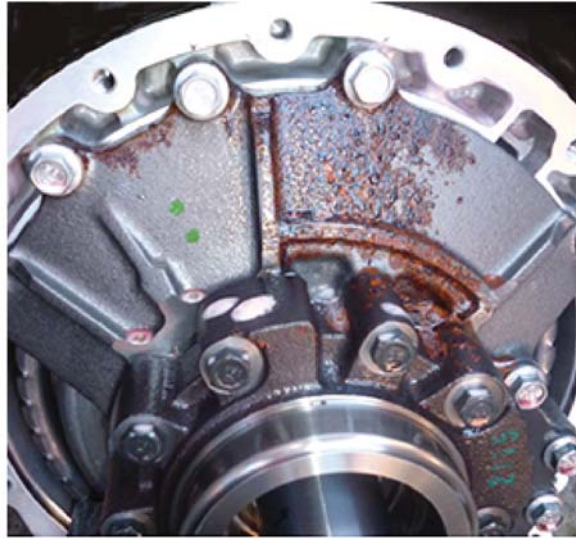
**Figure 5. Front Support Assembly With Damage**

**NOTE:** The transmission breather port is located directly above the Front Support Assembly. When water enters the transmission through the breather port, often there is physical evidence inside the Torque Converter Housing and on the face of the Front Support Assembly of this water entry (refer to [Figure 4](#)).

1. Take photos of the face of the Front Support Assembly as shown below (refer to [Figure 4](#) and [Figure 5](#)).

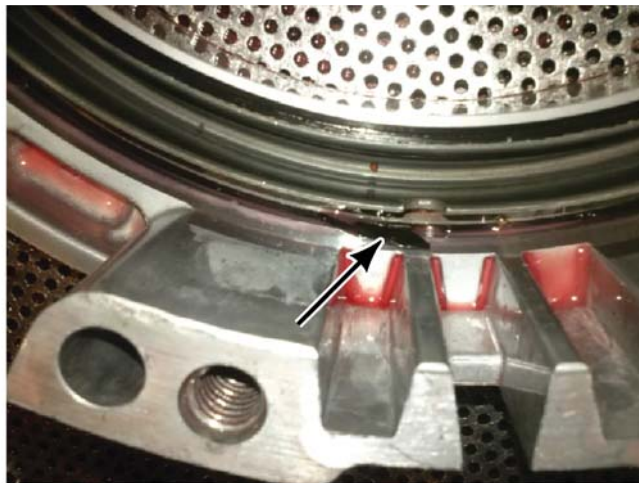
**Figure 8. Torn C4 Clutch Piston Seal**

Water or coolant intrusion into the transmission fluid can cause C3/C4 Bonded Piston failure in a 3000 series transmission.

3. Prior to removal of Bonded Piston P/N 29552373, take photos of C3/C4 Clutch Housings clearly showing the location of the tear in the seal (refer to [Figure 8](#)).
