TT7718EN, Rev. A  
October, 2015  
Page 1 of 2

**SUBJECT:** Shifting to Neutral and P0883 Code in Freightliner and Western Star Chassis

**MODELS AFFECTED:** 3000 and 4000 Series Product Family Transmissions in Freightliner and Western Star Trucks

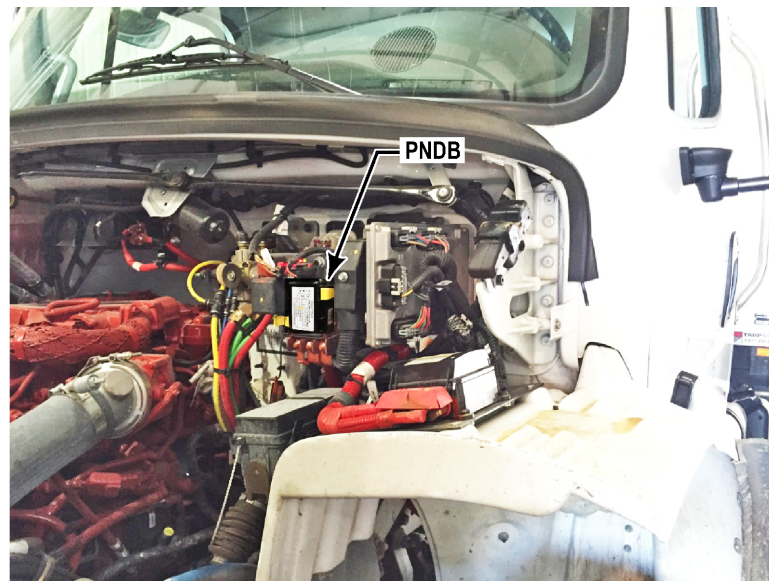
**Figure 1. Freightliner PowerNet Distribution (PNDB) Panel**

Loose fuses in the Freightliner or the Western Star PowerNet Distribution (PNDB) panel can cause TCM voltage to spike in excess of 16V. Refer to Figures 1 and 2.

If this issue is discovered while performing customer maintenance or repair, please refer the customer to a Freightliner or Western Star dealer to address the issue. Freightliner Service Bulletin 54-287 discusses this topic. Western Star Service Bulletin 54-60 discusses this topic.
