2014FA12  
May, 2015  
Page 1 of 5

SUBJECT: H 50 EP System™ Software Release to Improve Drive Unit Life in Transit Application

MODELS AFFECTED: H 50 EP System™ Transit Buses Equipped with Cummins ISB or ISL Engines MY 2007 or Newer

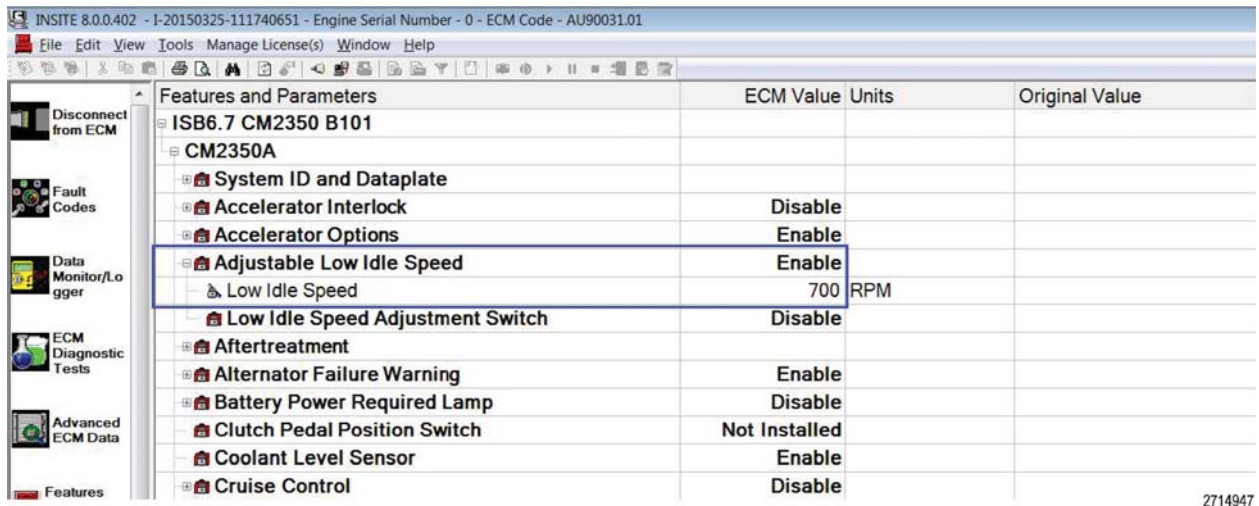
**Figure 2. Adjustable Low Idle Speed Configuration**

- Adjustable Low Idle Speed – Refer to [Figure 2](#)
  - Adjustable Low Idle Speed must be “**Enabled**”

- 3rd Generation Control Systems – Low Idle Speed MUST be set at “**700 RPM**”
- 4th Generation Control Systems – Low Idle Speed to be INITIALLY set at “**700 RPM**”.

**NOTE:** Figure 2 shows the Low Idle Speed to be set at 700 rpm. The Low Idle Speed may be set at 700 rpm or 750 rpm for 4th Generation control systems depending on OEM Customer Specification Sheets (CSS) request.

**NOTE:** 4th Generation Control Systems – If DTC 65-18 becomes active during the road test, reset the Low Idle Speed at 750 rpm. Some OEMs specify that the Low Idle Speed be set at 750 rpm. DTC 65-18 will set if an excessive mismatch exists between the actual engine rpm and the rpm specified in the calibration.
