TT7606EN  
February, 2015  
Page 1 of 2

**SUBJECT:** Unapproved Transmission Control Module (TCM) Mounting Location

**MODELS AFFECTED:** 3000 and 4000 Series Product Family Transmissions

**VOCATIONS AFFECTED:** Navistar TranStar and WorkStar vehicles with N13 Engines manufactured August 1, 2014 and after.

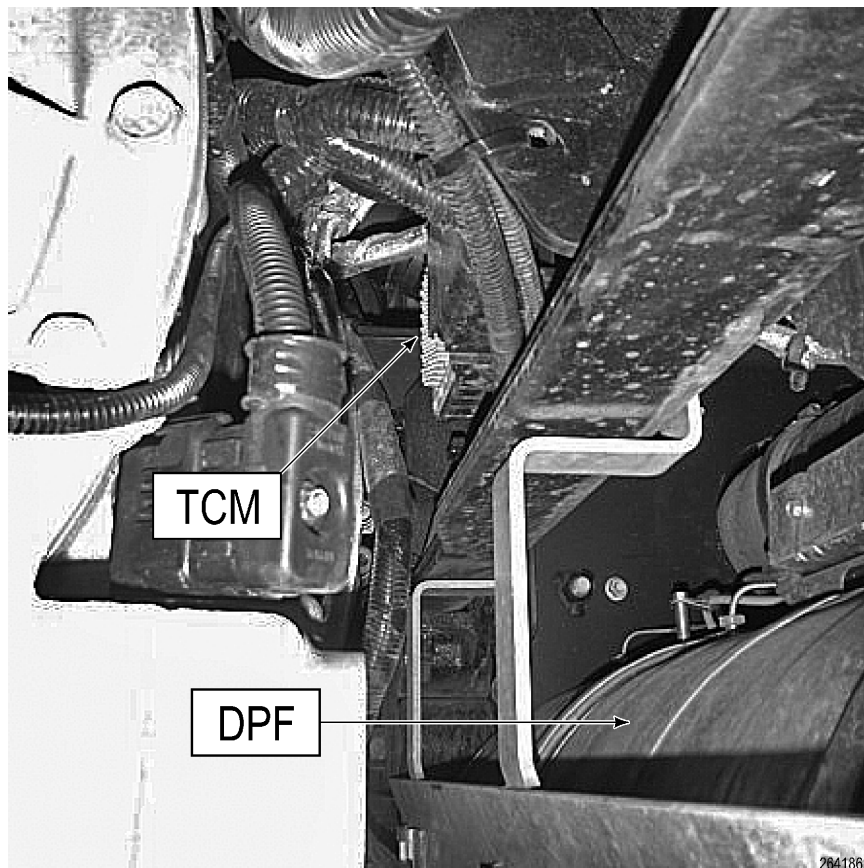
**Figure 1. Unapproved TCM Location**

Navistar TranStar and WorkStar vehicles manufactured with an N13 engine on August 1, 2014 and after may have the TCM mounted on the frame rail above and near the exhaust or diesel particulate filter (DPF) (refer to [Figure 1](#)).

A TCM mounted in the location as described above and depicted in [Figure 1](#) does not meet Allison Technical Data requirements and was not approved by Allison Transmission.

If an Allison customer brings their vehicle to your shop with an issue/complaint that is a result of a TCM issue or requires TCM replacement, the repair/replacement will not be covered by Allison Transmission Warranty, Partner and ETC coverage. The customer should be directed to a Navistar Dealer to address their issue.
