TT7718EN  
October, 2015  
Page 1 of 2

**SUBJECT:** Shifting to Neutral and P0883 Code in Freightliner Chassis

**MODELS AFFECTED:** 3000 and 4000 Series Product Family Transmissions in Freightliner Trucks

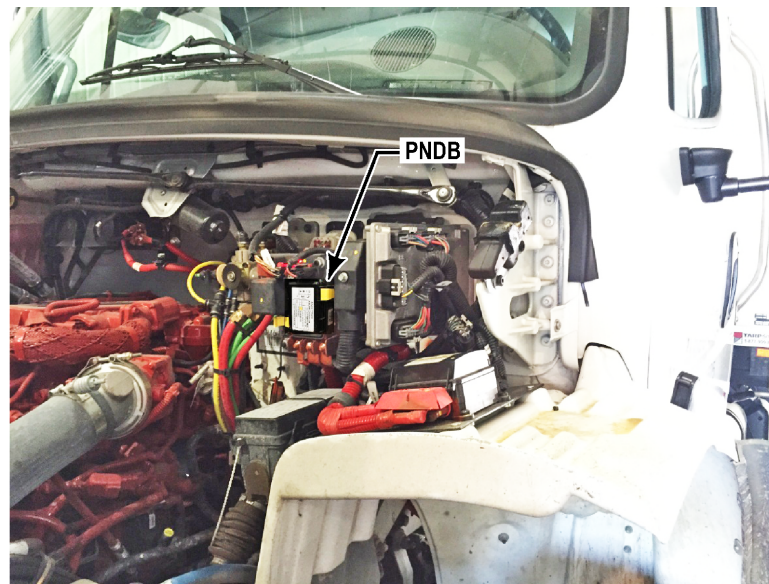
**Figure 1. PowerNet Distribution (PNDB) Panel**

Loose fuses in the Freightliner PowerNet Distribution (PNDB) panel can cause TCM voltage to spike in excess of 16V. Refer to Figures 1 and 2.

If this issue is discovered while performing customer maintenance or repair, please refer the customer to a Freightliner dealer to address the issue. Freightliner Service Bulletin 54-287 discusses this topic.
