NUMBER: 23-041-15

Window Switch Bezels Etched - Clear/White Spots

2015 (VM) Ram ProMaster City

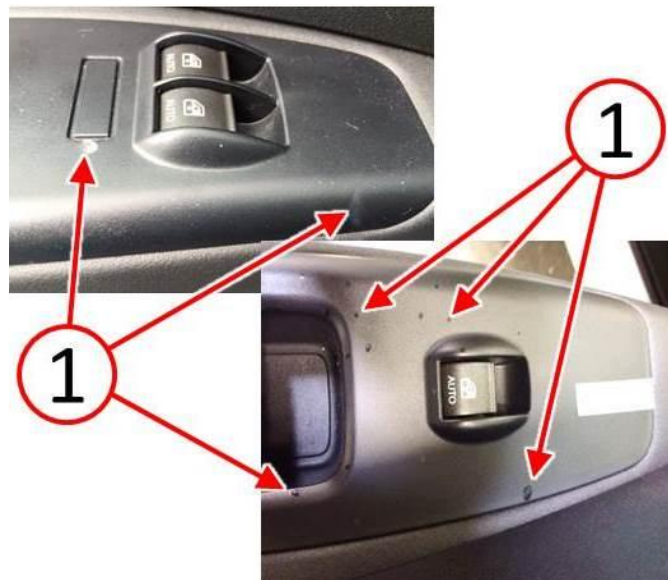
Fig. 1 Inspect For Spots

The customer may describe clear and/or white spots on the front window switch bezels.

1. Inspect the front door window switch bezels for clear and/or white spots (Fig. 1).

1 - Clear And/Or White Spots

2. Are clear and/or white spots visible on one or both of the front window switch bezels?
 - a. YES>>> Replace the affected power window switch(es). Continue with the Repair Procedure [Step #3](#).
 - b. NO>>> This bulletin has been completed. Use LOP (08-80-54-91) to close the active RRT.
3. Replace the affected power window switch(es) (Fig. 2). Refer to the detailed service procedures available in DealerCONNECT> TechCONNECT under: Service Info> 08 - Electrical> 8N - Power Systems> Power Windows> Switch, Power Window> Removal and Installation.
