NUMBER: 08-108-15

Vehicle System Interface Module Unresponsive

This bulletin involves reprogramming the Vehicle System Interface Module (VSIM) with the latest available software.

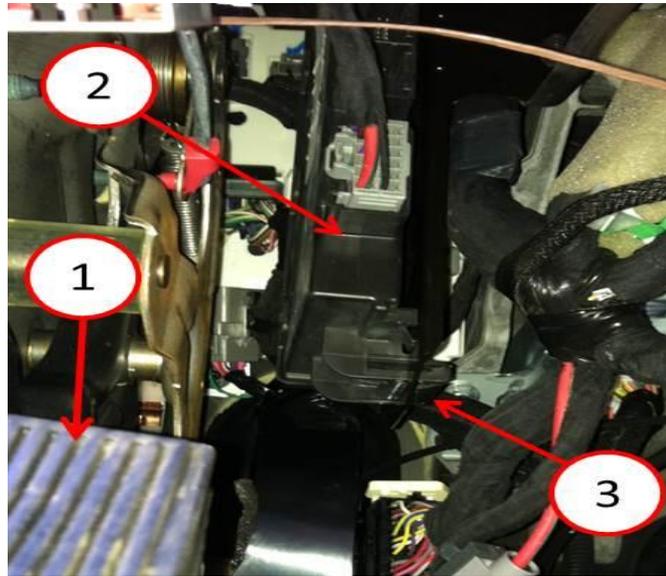
Fig. 1 Location Of VSIM and Release Tab

1. Use wiTECH to check if the VSIM is active on the Bus.
2. Is the VSIM active on the Bus?
 - a. Yes >>> Proceed to [Step #8](#).
 - b. No >>> Proceed to [Step #3](#).
3. Lower the VSIM and disconnect the connector to reset the module.
4. The VSIM is located under the dash next to the park brake pedal, see ([Fig. 1](#)).

- 1 - Park Brake Pedal
- 2 - VSIM
- 3 - Module Release Tab

-
5. Press up on the module release tab and lower the VSIM. Disconnect the VSIM connector for 30 seconds.
 6. Reconnect the VSIM and return it to the mounting bracket.
 7. Is the VSIM active on the Bus?
 - a. Yes >>> Proceed to [Step #8](#).
 - b. No >>> This bulletin does not apply. Perform diagnostic for No Response From VSIM.
 8. Reprogram the VSIM with the latest available software. Detailed instructions for flashing control modules using the wiTECH Diagnostic Application are available by selecting the "HELP" tab on the upper portion of the wiTECH window, then "HELP CONTENTS." This will open the Welcome to wiTECH Help screen where help topics can be selected.
 9. Clear all DTCs that may have been set in any module due to reprogramming. The wiTECH application will automatically present all DTCs after the flash and allow them to be cleared.
