NUMBER: 23-043-15

Liftgate Contacts Roof

This bulletin involves adjusting the liftgate hinge.

2015 (JC) Dodge Journey

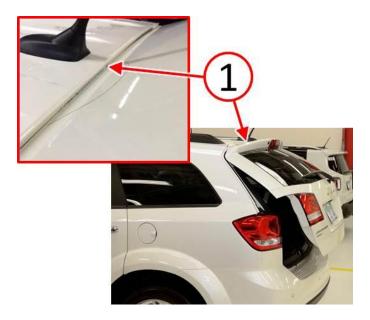
Fig. 1 Location Of Contact Between Liftgate To Roof

1. Open the liftgate slowly while inspecting for contact between the liftgate and the roof near the center of the vehicle at the location shown in (Fig. 1).

1 - Contact Location

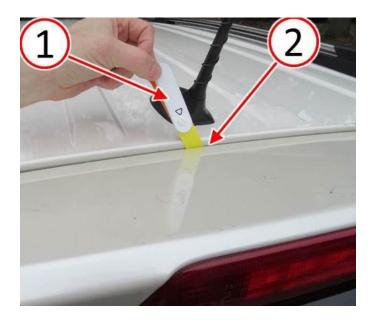
Fig. 2 Inspect For Clearance Between Liftgate To Roof

- 3. Open the liftgate approximately half way until the gap near the center of the vehicle between the liftgate and the roof is at the closest position.
- 4. Attempt to pass a 0.5 mm (0.02 in.) non-metallic clearance measurement gauge (1) along the gap (2) between the liftgate and the roof while concentrating on the most center area where the gap is at a minimum (Fig. 2).
- 5. Did the feeler gauge pass freely without drag or hesitation?
 - a. YES>>> This bulletin has been completed, use LOP (23-00-30-92) to close the active RRT.
 - b. NO>>> Continue with the Repair Procedure Step #6.

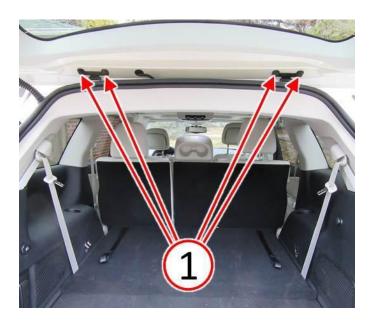
Fig. 3 Liftgate Hinge Adjustment

1 - Liftgate Hinge Bolts

- 1 Non-Metallic Clearance Measurement Gauge
- 2 Gap Between The Liftgate And The Roof
- 6. Loosen the bolts (1) securing the hinge to liftgate (Fig. 3).
- 7. Move the liftgate away from the vehicle body while utilizing a non-metallic clearance measurement gauge to determine when 0.5 mm (0.02 in.) of clearance between the liftgate and the roof has been achieved. Do not exceed 7.7 mm (0.30 in.) gap between the liftgate and the roof with the liftgate closed per the gap and flush specifications available in DealerCONNECT> TechCONNECT under: Service Info> 23 Body> Body Structure> Gap and Flush> Specifications.
- 8. Tighten the bolts (1) to 28 N·m (21 ft. lbs.) (Fig. 3).

9. Retest the gap as described in Step #3 and Step #4. If contact still occurs, return to Step #6. If contact is not noticed and the 0.5 mm (0.02 in.) non-metallic clearance measurement gauge passes freely between the liftgate and the roof, the Repair Procedure has been completed.
