NUMBER: 23-045-15

Poor Adhesion Of The Chrome RAM Emblem Letters To The Tailgate

2015 (DS) Ram 1500 Pickup

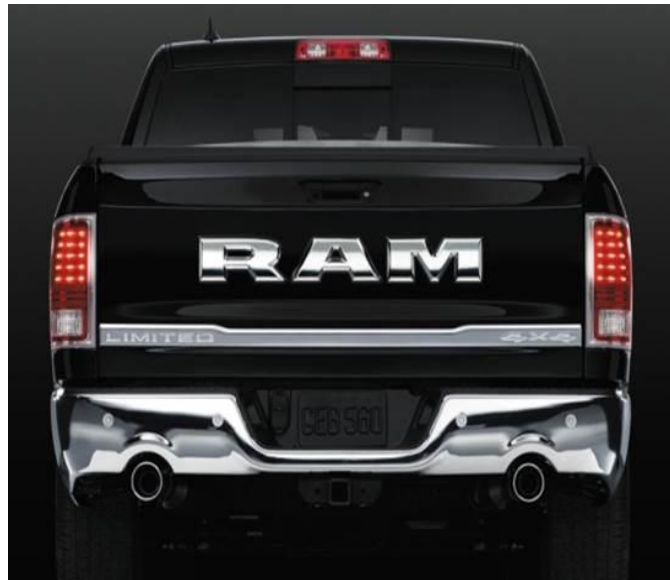
Fig. 1 RAM lettering on tailgate

The customer may describe what appears to be a gap between the RAM lettering and the tailgate of the vehicle.

The RAM lettering emblems may separate from the tailgate due to insufficient adhesive bond strength.
