NUMBER: 18-095-15

DATE: November 25, 2015

Flash: 3.0L Powertrain Diagnostic And System Enhancements

2015 (WK) Jeep Grand Cherokee

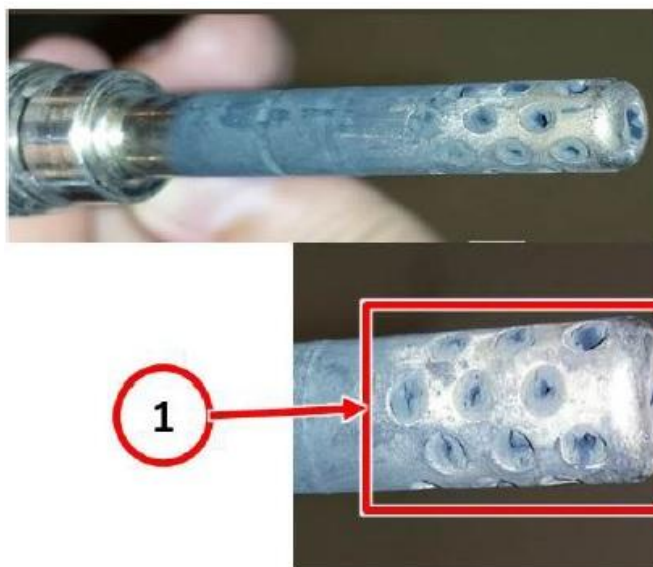
Fig. 1 EGT Sensor Bank 1 Sensor 1

11. Inspect the sensor body and probe for any signs of damage or excessive soot. See (Fig. 1).

1 - Excessive soot blocking sensor ports

-
12. Was excessive soot found on the sensor?
- Yes>>> Proceed to [Step #13](#).
 - No>>> Proceed to [Step #14](#).
13. Using shop air set to a maximum of 80 psi, clean all excessive soot from the sensor probe.

14. Using a suitable multi-meter with appropriate test probes, test the resistance between the sensor connector terminals 1 and 2. With the sensor at room temperature, 65-75 °F (18-25 °C), the resistance should measure between 200 and 240 ohms.
