**NUMBER:** 18-094-15

Flash: 3.0L Powertrain Diagnostic and System Improvements

2014                      (WK)                      Jeep Grand Cherokee

**NOTE: This bulletin applies to vehicles equipped with a 3.0L diesel engine (Sales Code EXF) and 8 speed transmission (Sales Code DFD).**

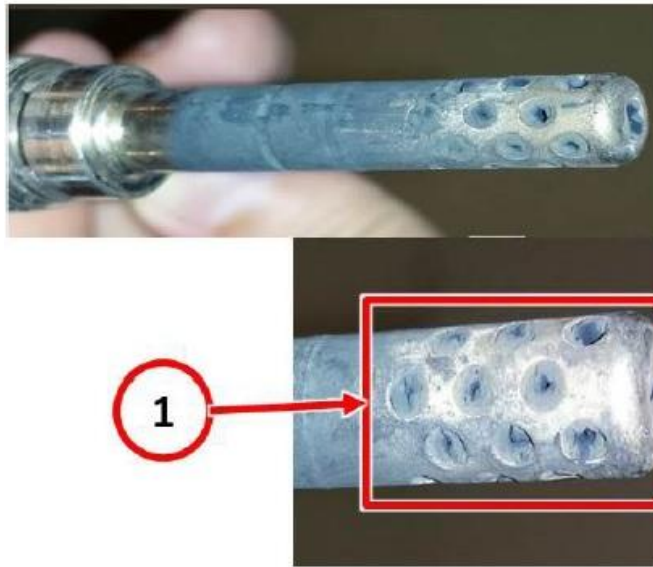
**Fig. 1 EGT Sensor Bank 1 Sensor 1**

10. Remove the EGT Sensor 1/2 located in the inlet of the Diesel Particulate Filter (DPF)/Diesel Oxidation Catalyst (DOC) assembly. Refer to detailed removal procedures available in DealerCONNECT> TechCONNECT> Service Info Section 11 - Exhaust System> Sensor, Exhaust Temperature> Removal> Exhaust Gas Temperature Sensor 1/2.
11. Remove the Catalyst Temperature Sensor located in the middle of the Diesel Particulate Filter (DPF)/Diesel Oxidation Catalyst (DOC) assembly. Refer to detailed removal procedures available in DealerCONNECT> TechCONNECT> Service Info Section 11 - Exhaust System> Sensor, Exhaust Temperature> Removal> Catalyst Exhaust Temperature Sensor.
12. Inspect the sensor body and probe for any signs of damage or excessive soot. See (Fig. 1).

1 - Excessive soot blocking sensor ports

- 
13. Was excessive soot found on the sensor?
    - a. Yes>>> Proceed to [Step #14](#).
    - b. No>>> Proceed to [Step #15](#).
  14. Using shop air set to a maximum of 80 psi, clean all excessive soot from the sensor probe.
  15. Using a suitable multi-meter with appropriate test probes, test the resistance between the sensor connector terminals 1 and 2. With the sensor at room temperature, 65-75 °F (18-25 °C), the resistance should measure between 200 and 240 ohms.
  16. Is the temperature sensor resistance within specifications?
    - a. Yes>>> Install the original EGT sensor 1/2 and/or Catalyst Temperature Sensor. Refer to detailed installation procedures available in DealerCONNECT> TechCONNECT> Service Info Section 11 - Exhaust System> Sensor, Exhaust Temperature> Installation> Exhaust Gas Temperature Sensor 1/2.

- b. No>>> Install a new EGT sensor 1/2 and/or Catalyst Temperature Sensor. Refer to detailed installation procedures available in DealerCONNECT> TechCONNECT> Service Info Section 11 - Exhaust System> Sensor, Exhaust Temperature> Installation> Exhaust Gas Temperature Sensor 1/2.
